Bridges near trees

Case study: Southampton case study

Reading case study

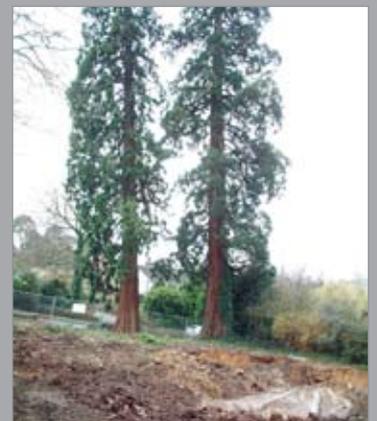
The bungalow had to be carefully demolished ready for fencing the trees to prevent accidental damage to their trunks.

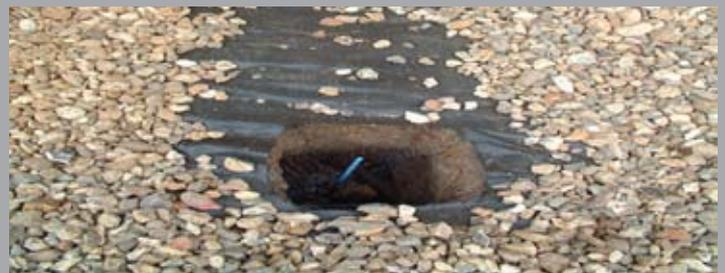
The pile locations were all hand dug to a depth of 0.75m to ensure that no large roots would be damaged. If roots were found, the pile locations were shifted to avoid them.

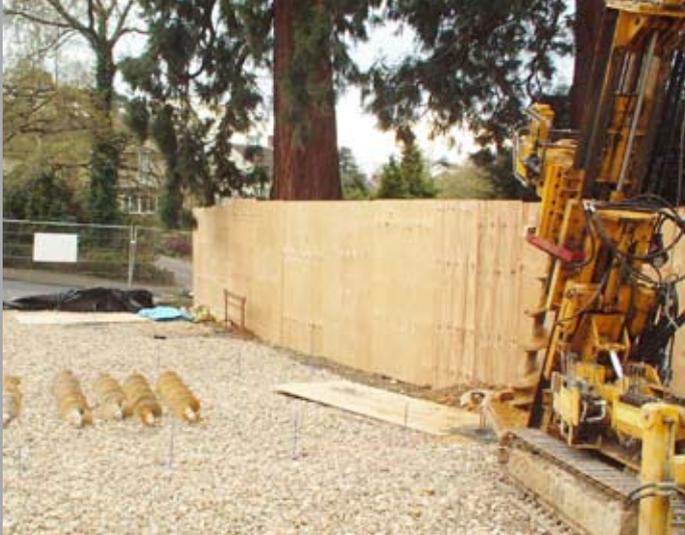
The piling rig was lightweight and its load spread by a temporary surface installed specifically for the process. The auger drilled out the holes, which were then filled with reinforcing steel and concrete to form the piles.

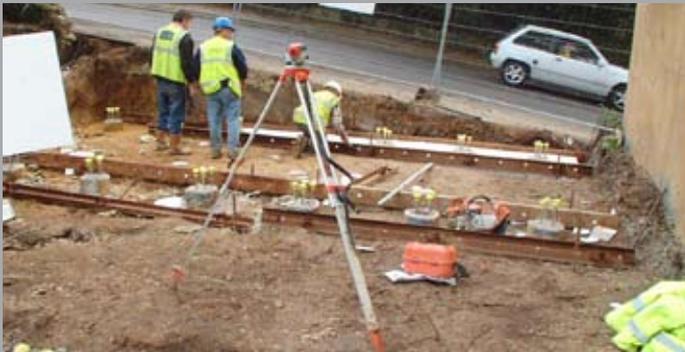
The rows of piles across the entrance were then connected by a concrete beam, which supported the main bridge structure above the ground, thus protecting the sensitive rooting area for the trees.

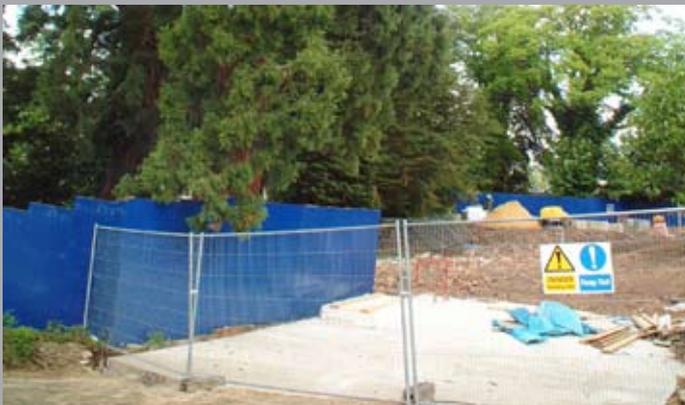
The concrete bridge is cast on top of the piles (2003) ready for the final surfacing.

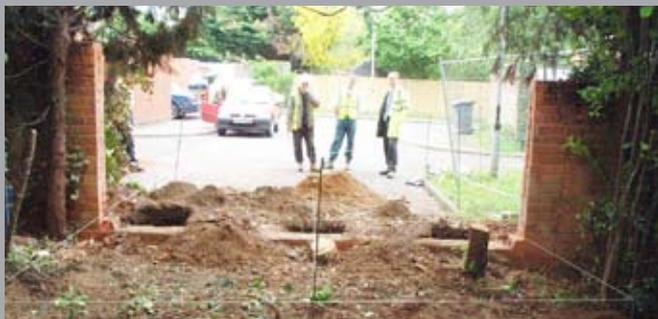
Work started in 2003 by cutting the wall at each side of the access and carefully removing the top, leaving the footings still in the ground to avoid damaging roots. The pile holes were dug by hand to 0.75m depth to ensure that no significant roots had to be cut.

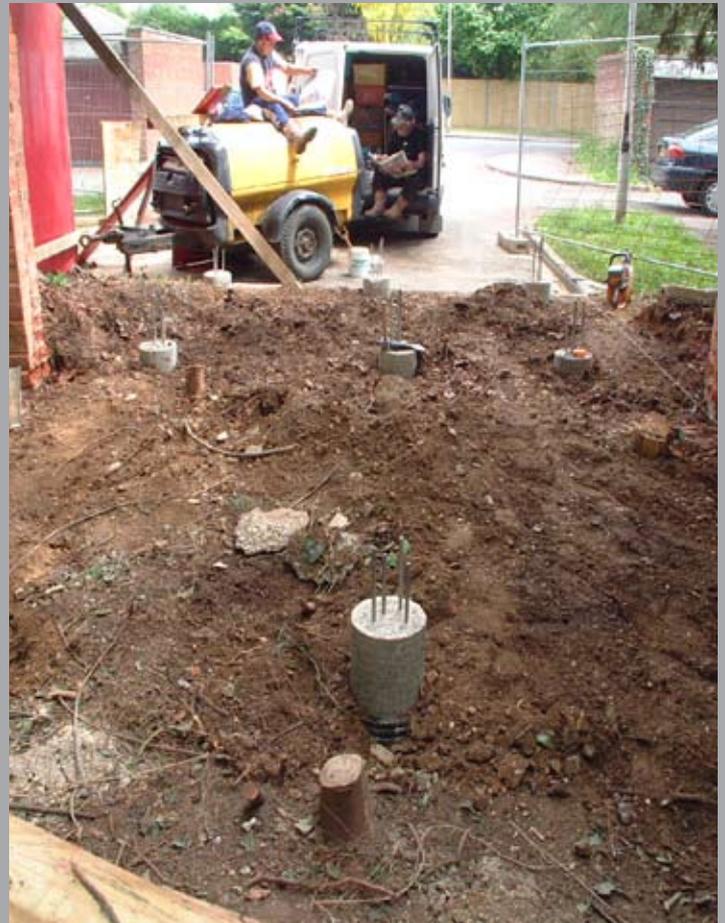
The small diameter piles were installed by a lightweight machine, with their tops sticking out of the ground ready for the fitting of the concrete roadway.

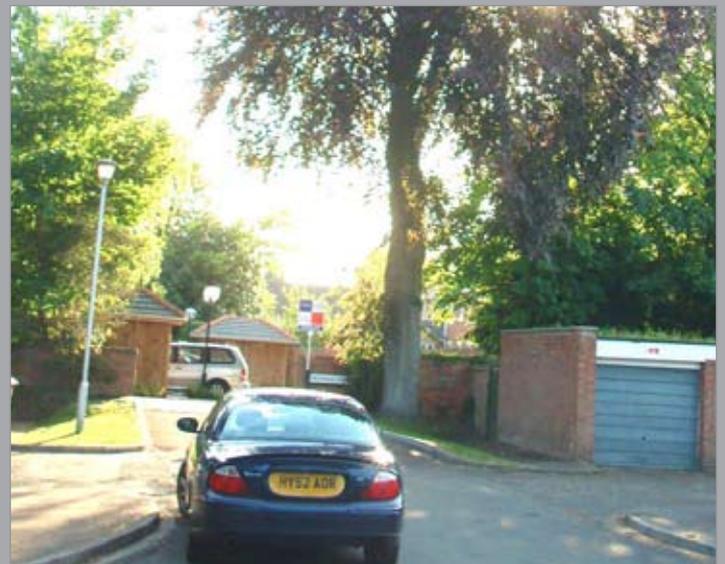
The concrete bridge was cast above ground level, supported by the piles, and the tree is still healthy in 2008.
