Bridges near trees

TREE CONSULTANCY

Case study: Southampton case study

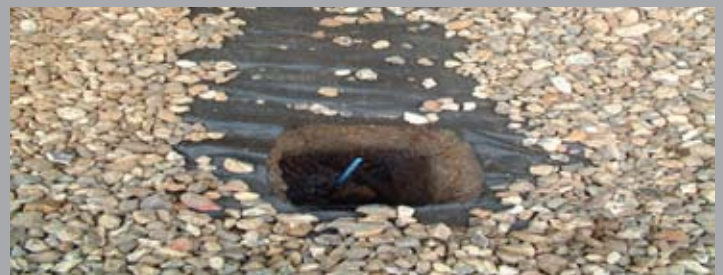
The pile locations were all hand dug to a depth of 0.75m to ensure that no large roots would be damaged. If roots were found, the pile locations were shifted to avoid them.

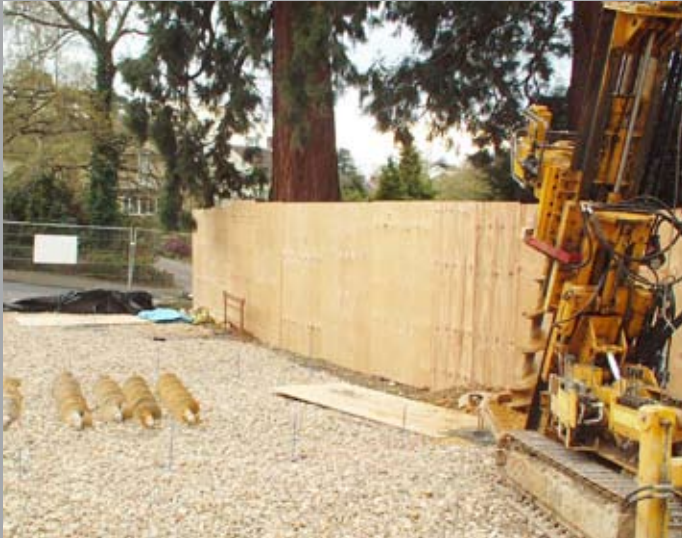
The piling rig was lightweight and its load spread by a temporary surface installed specifically for the process. The auger drilled out the holes, which were then filled with reinforcing steel and concrete to form the piles.

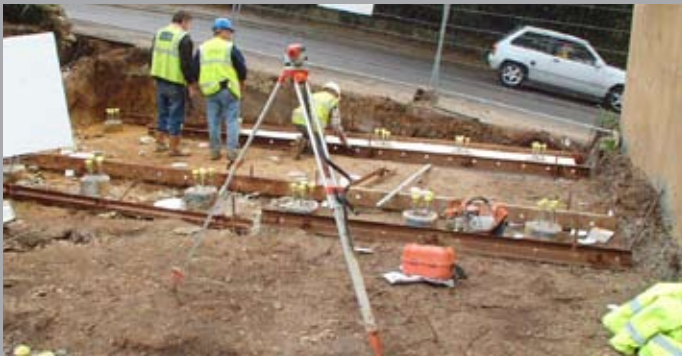
The rows of piles across the entrance were then connected by a concrete beam, which supported the main bridge structure above the ground, thus protecting the sensitive rooting area for the trees.

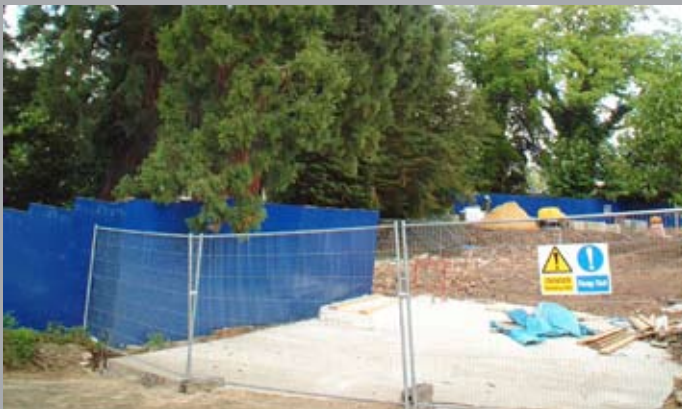
The concrete bridge is cast on top of the piles (2003) ready for the final surfacing.

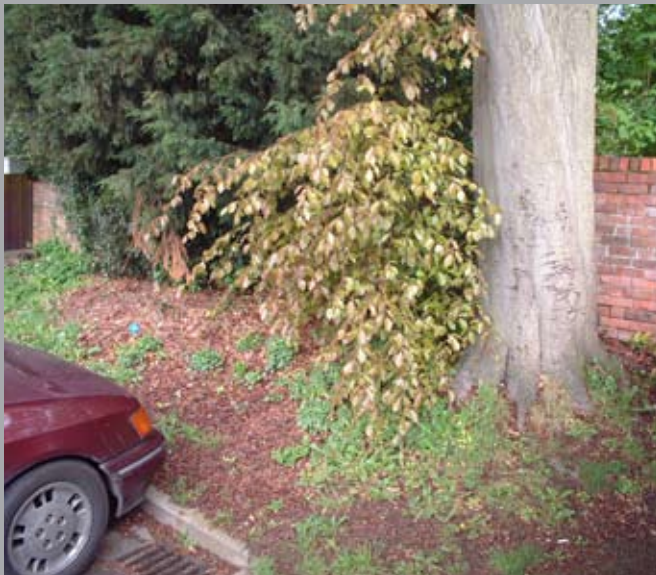
The new access had to be a continuation of the existing road through the wall to the left of the tree.

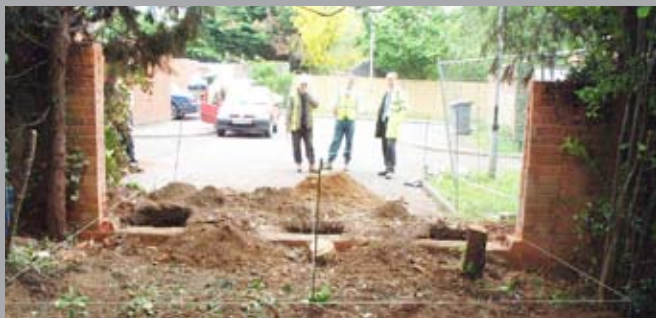
Work started in 2003 by cutting the wall at each side of the access and carefully removing the top, leaving the footings still in the ground to avoid damaging roots. The pile holes were dug by hand to 0.75m depth to ensure that no significant roots had to be cut.

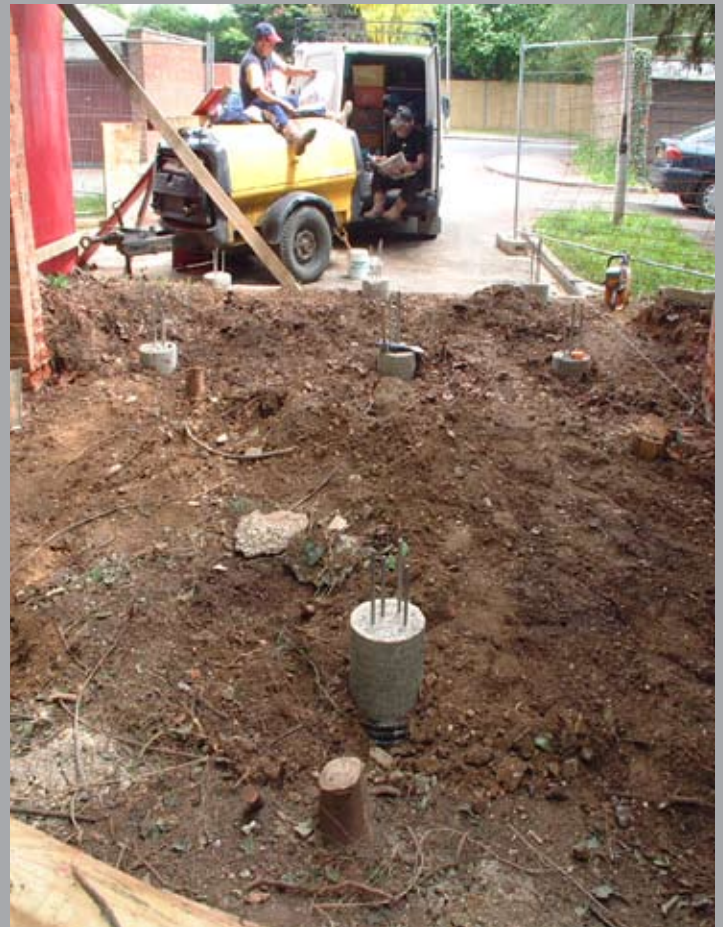
The small diameter piles were installed by a lightweight machine, with their tops sticking out of the ground ready for the fitting of the concrete roadway.

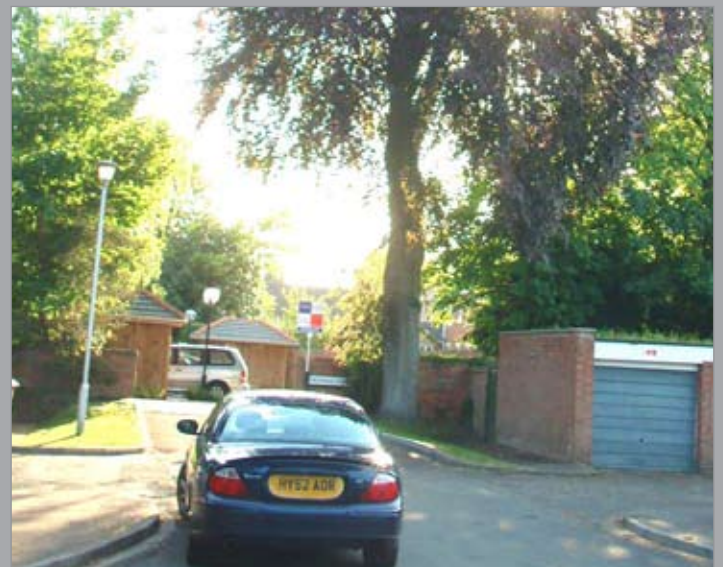
The concrete bridge was cast above ground level, supported by the piles, and the tree is still healthy in 2008.
