Surfacing near trees

TREE CONSULTANCY

Case study: How not to do it!

Poole case study

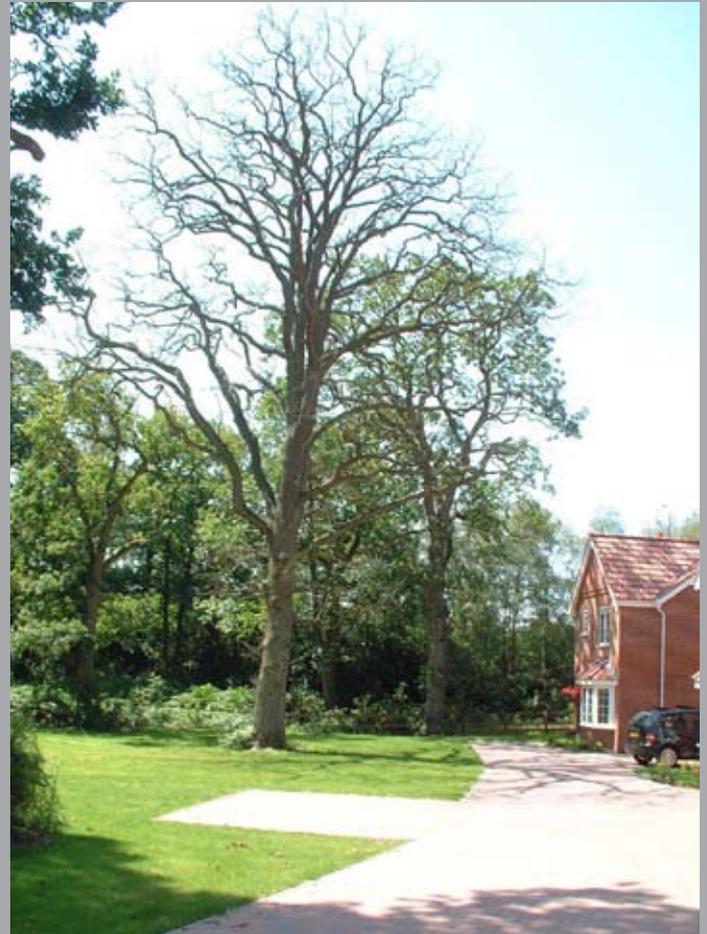
Poor design and incorrect installation of new surfacing often kills nearby trees.

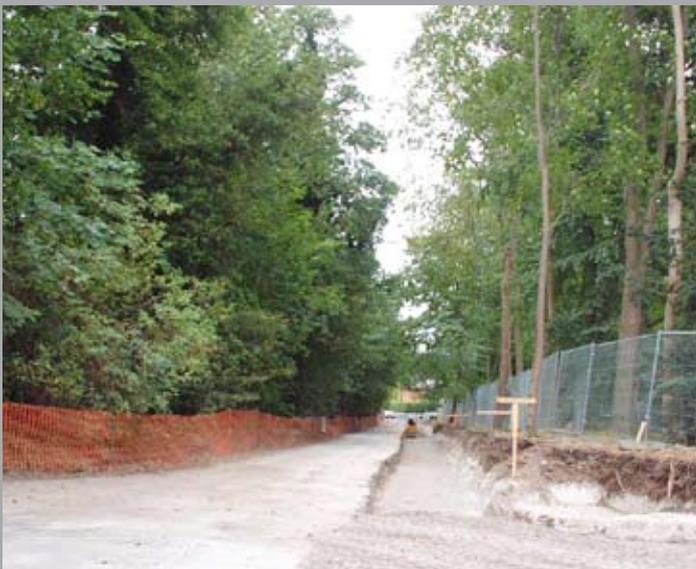
Conventional installation of new surfacing by digging out about 50cm of soil and then filling with compacted stone is not tree-friendly and often results in their removal.

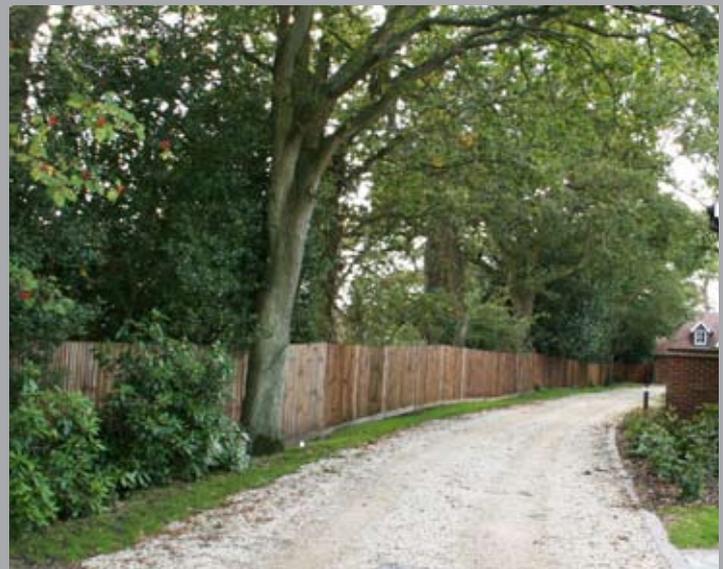
In contrast, using a cellular confinement system filled with stone installed directly onto the ground surface without any excavation often has no significant impact on nearby trees.

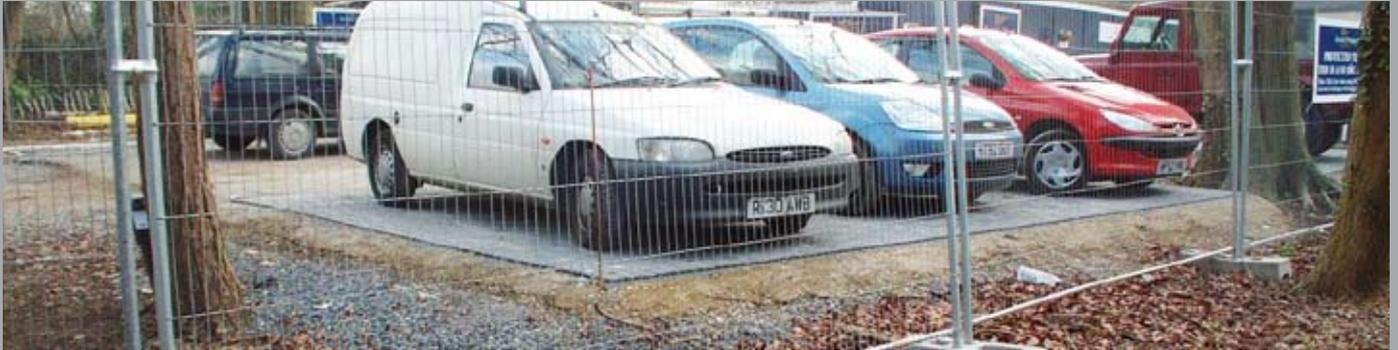
If permeable to water and gasses and it is set on top of the existing ground level, new surfacing beneath trees is a very effective way of maximising the use of precious space.

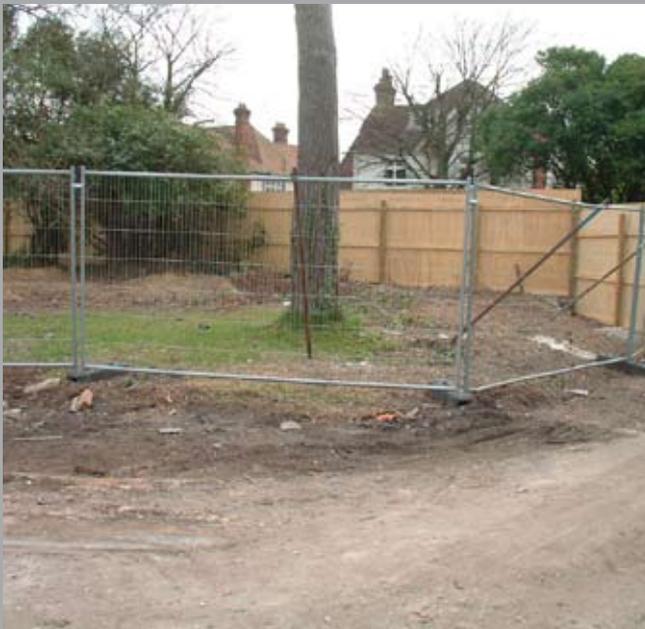
The council granted consent to put no-dig surfacing close to the trunk of this mature Scots pine. However, the very low existing entrance drive level meant that this area would need raising by up to 75cm to allow vehicular access to the new surfacing on the grass beneath the tree.

Digging near mature trees damages long-established roots and often kills or destabilises them. Care at the design stage is necessary to make sure the proposed surfacing will sit on top of the existing ground, but still fit in with other surfacing and structures around it. In this case, the surrounding surfacing levels were so low that deep excavation was needed near the mature Scots pine. It was so badly damaged that it is now in decline and its life expectancy has been significantly reduced.

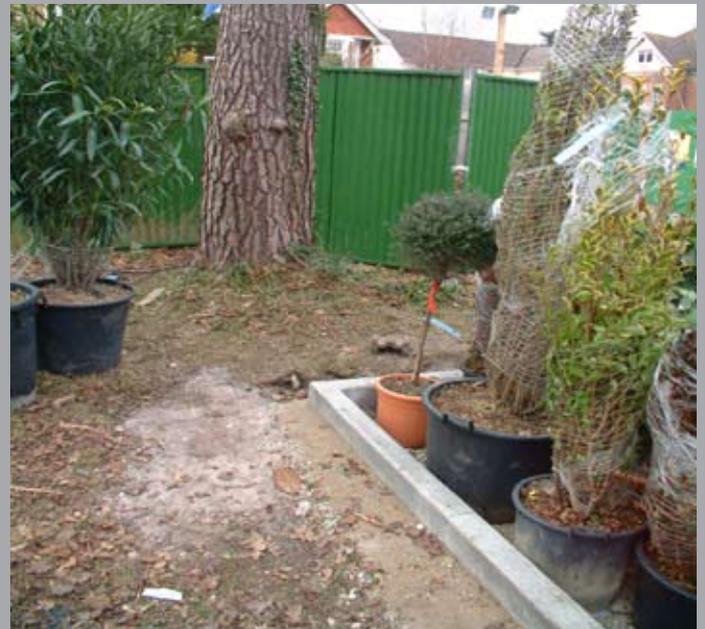
In practice, this was not feasible and the new surfacing was dug in by more than 30cm, causing the loss of important roots. The tree is still alive, but its health has been badly compromised. It could have been retained for much longer if the surfacing had been properly planned and installed.

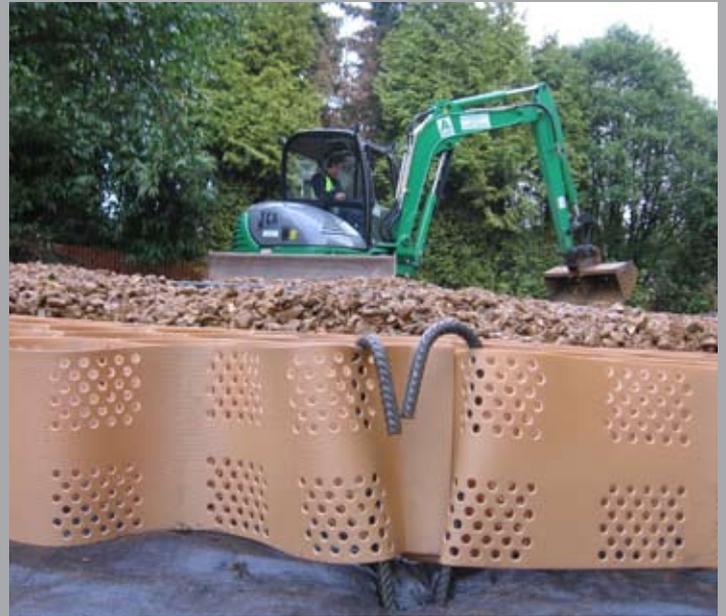
The cells have side perforations to allow the movement of water and air.

Consent for a temporary access road to service the construction of a new nursing home development was granted in 2005. The road went through a belt of mature trees that were prominent in the landscape and the council wanted them retained without any damage. The temporary road was installed using a cellular confinement system laid directly onto the soil surface without any excavation. Investigations into tree health and soil conditions in 2007 showed no adverse impact on the trees or their roots growing beneath the road.

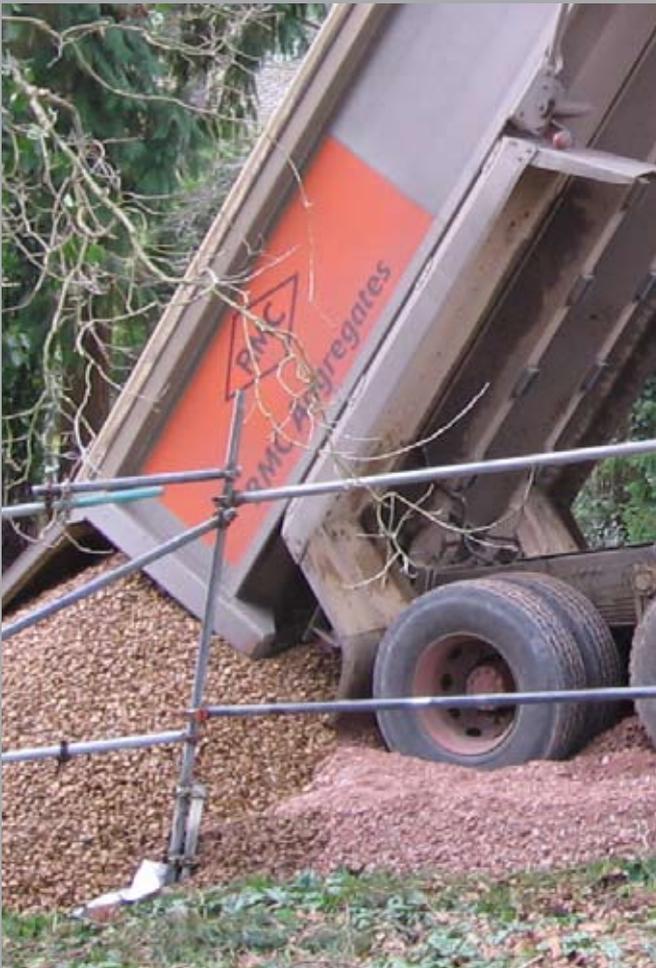
The rigid array of cells can effectively spread the weight of a loaded lorry as soon as they are filled.

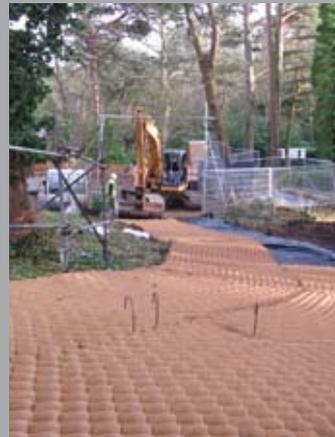
The flexible cells are pinned out onto the soil surface without any excavation.

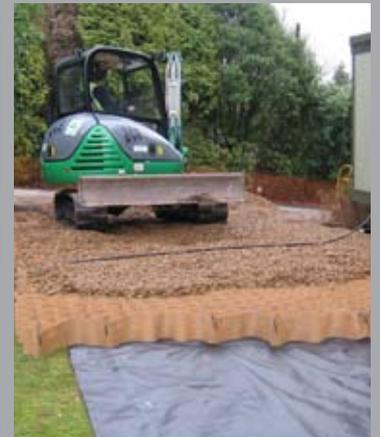
The stone is spread over the area of cells until they are all full, forming an interlocking and rigid grid that spreads the load.

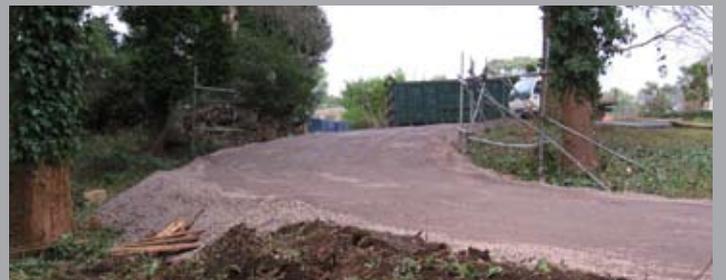
The permeable wearing surface is installed on top of the filled cells and profiled for safe vehicular use.

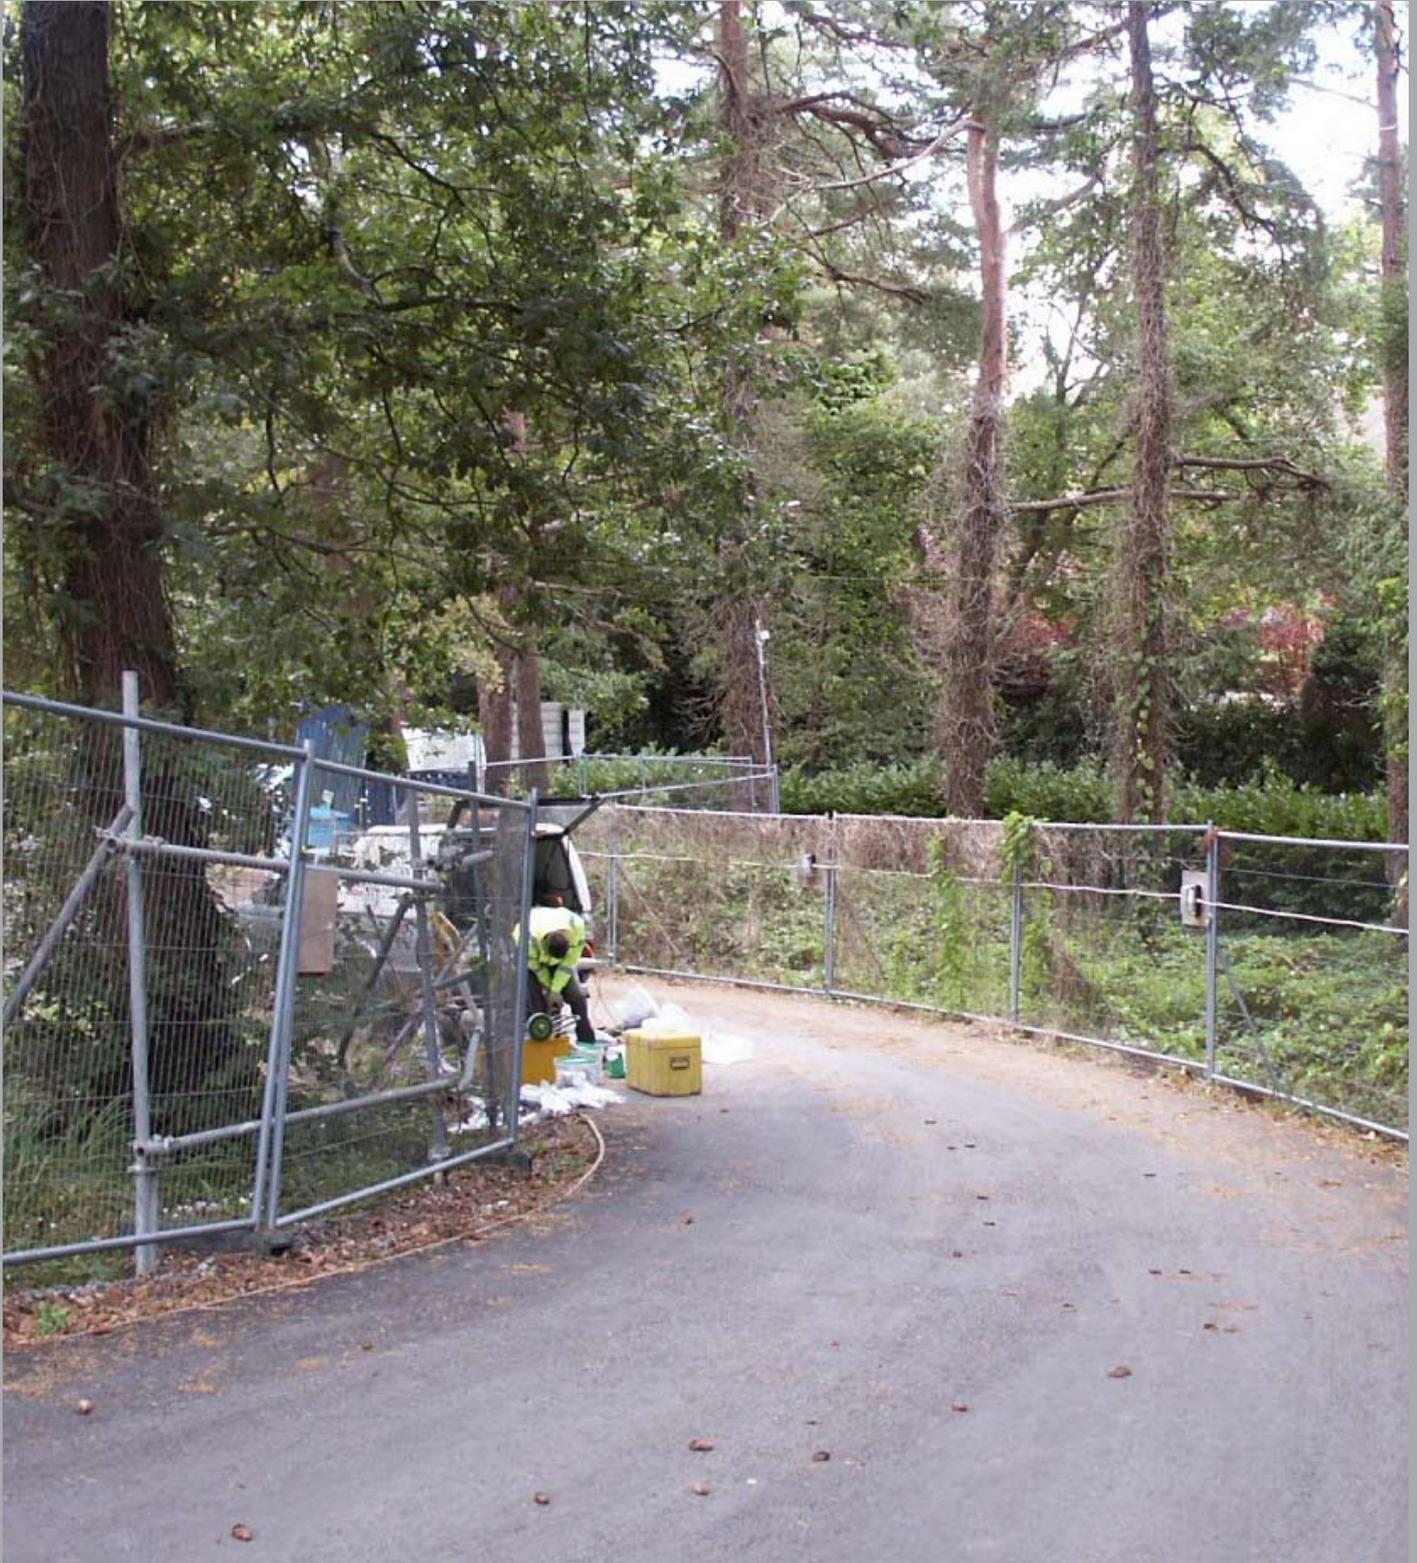
Two years on, the surface is still in use with no adverse impact on the adjacent trees.
