Surfacing near trees

TREE CONSULTANCY

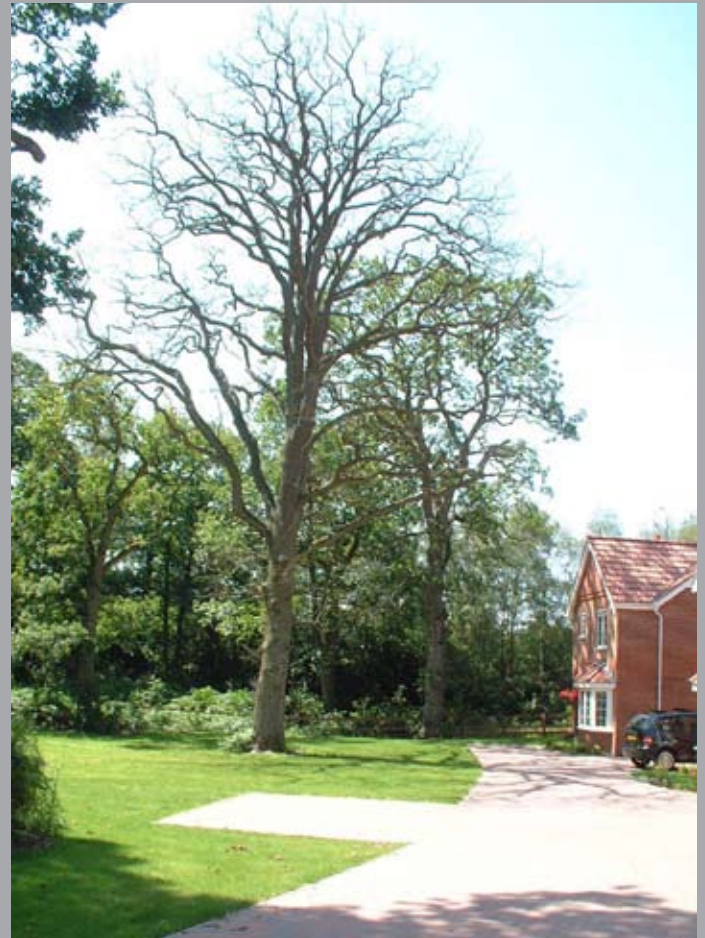
Poor design and incorrect installation of new surfacing often kills nearby trees.

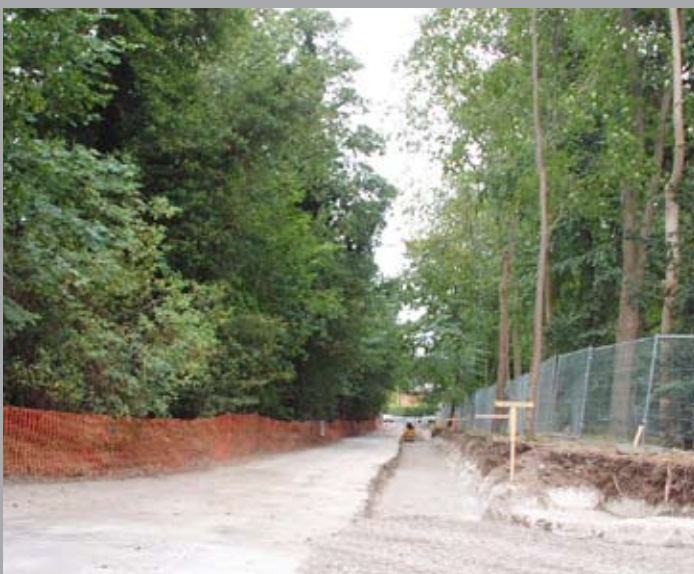
Conventional installation of new surfacing by digging out about 50cm of soil and then filling with compacted stone is not tree-friendly and often results in their removal.

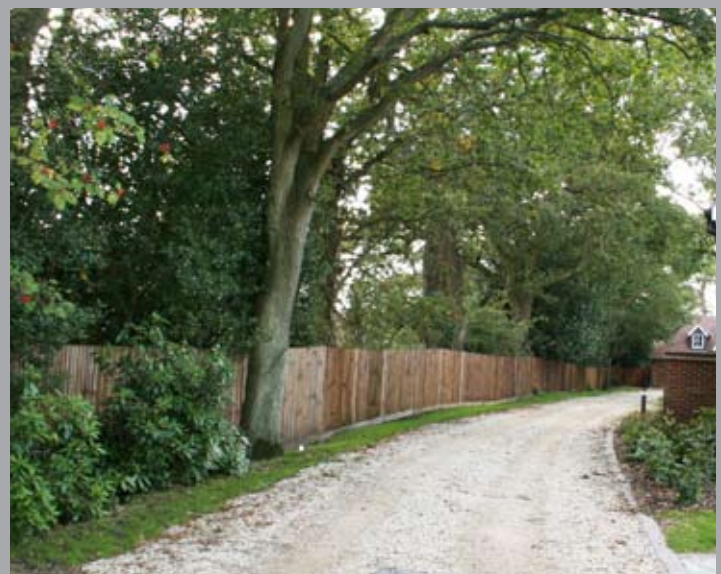
In contrast, using a cellular confinement system filled with stone installed directly onto the ground surface without any excavation often has no significant impact on nearby trees.

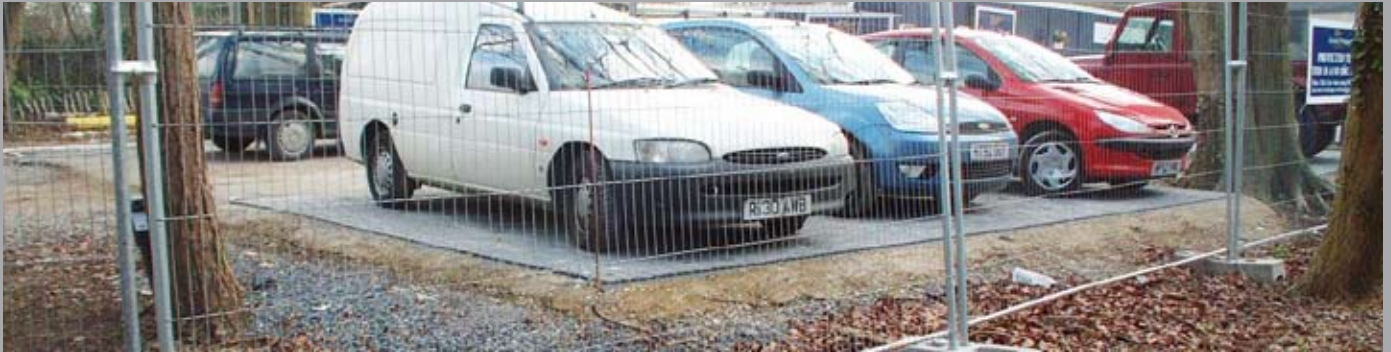
If permeable to water and gasses and it is set on top of the existing ground level, new surfacing beneath trees is a very effective way of maximising the use of precious space.

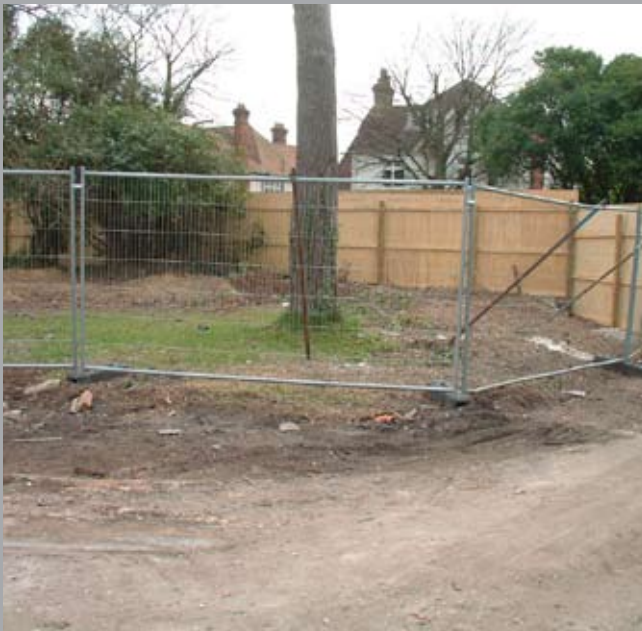
The council granted consent to put no-dig surfacing close to the trunk of this mature Scots pine. However, the very low existing entrance drive level meant that this area would need raising by up to 75cm to allow vehicular access to the new surfacing on the grass beneath the tree.

Digging near mature trees damages long-established roots and often kills or destabilises them. Care at the design stage is necessary to make sure the proposed surfacing will sit on top of the existing ground, but still fit in with other surfacing and structures around it. In this case, the surrounding surfacing levels were so low that deep excavation was needed near the mature Scots pine. It was so badly damaged that it is now in decline and its life expectancy has been significantly reduced.

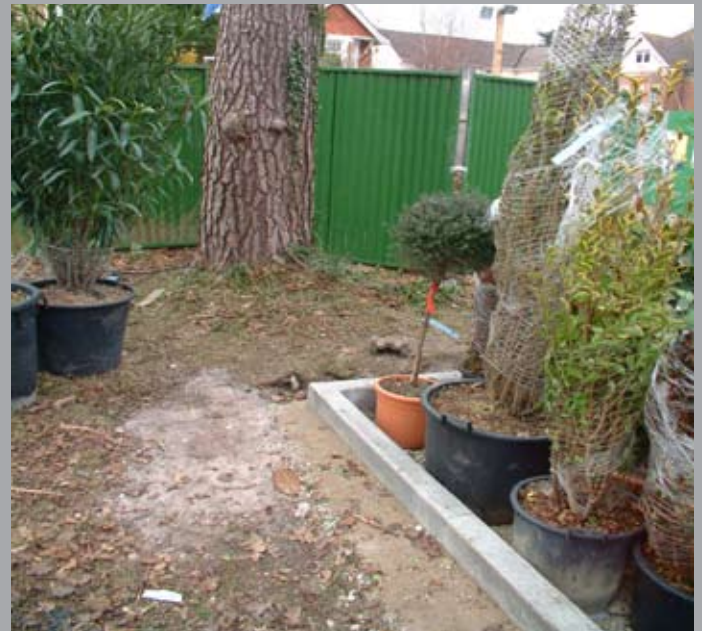
In practice, this was not feasible and the new surfacing was dug in by more than 30cm, causing the loss of important roots. The tree is still alive, but its health has been badly compromised. It could have been retained for much longer if the surfacing had been properly planned and installed.

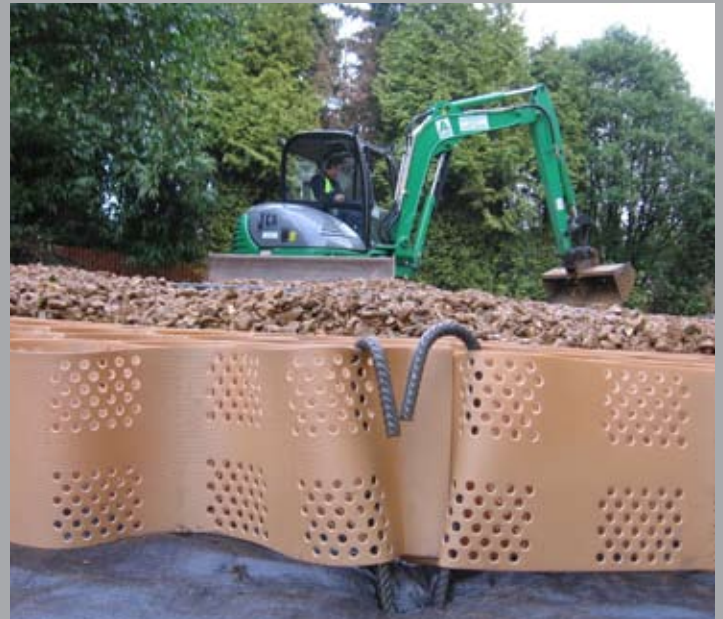
The cells have side perforations to allow the movement of water and air.

Consent for a temporary access road to service the construction of a new nursing home development was granted in 2005. The road went through a belt of mature trees that were prominent in the landscape and the council wanted them retained without any damage. The temporary road was installed using a cellular confinement system laid directly onto the soil surface without any excavation. Investigations into tree health and soil conditions in 2007 showed no adverse impact on the trees or their roots growing beneath the road.

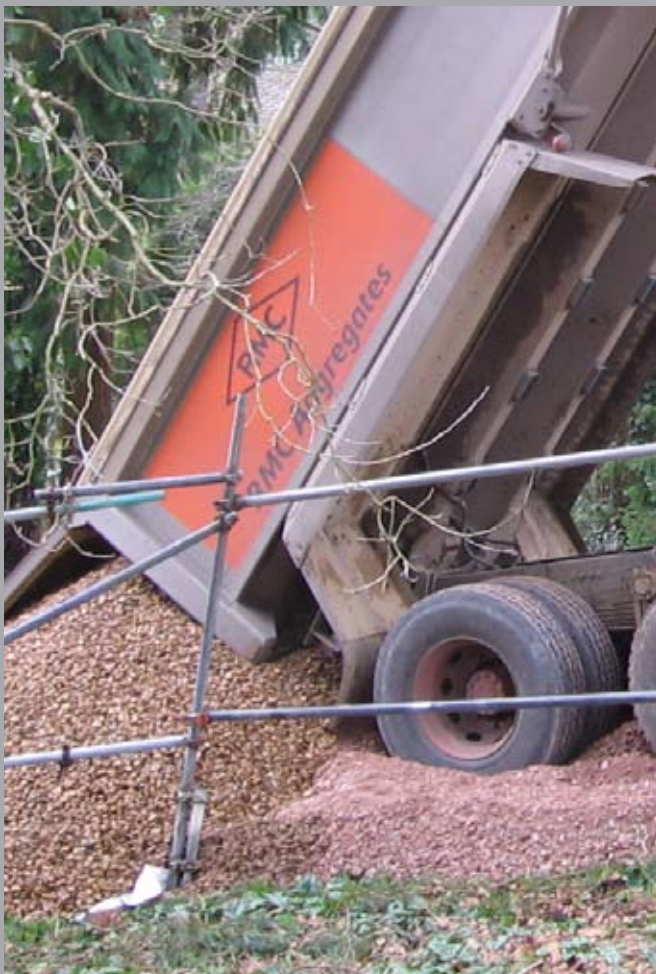
The rigid array of cells can effectively spread the weight of a loaded lorry as soon as they are filled.

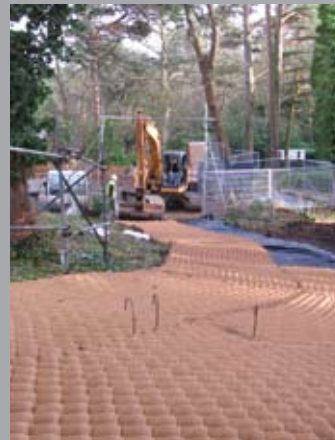
The flexible cells are pinned out onto the soil surface without any excavation.

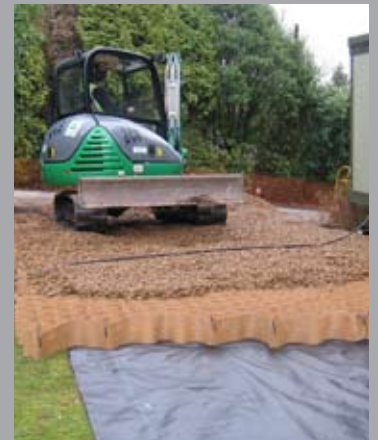
The stone is spread over the area of cells until they are all full, forming an interlocking and rigid grid that spreads the load.

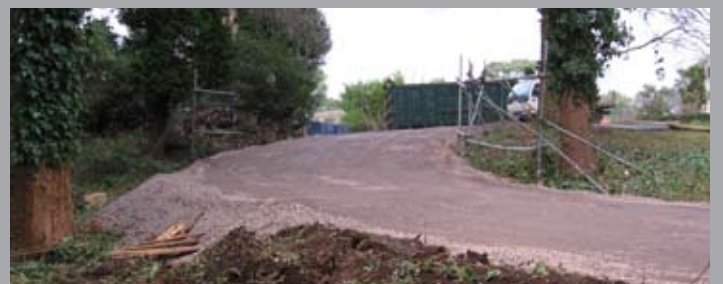
The permeable wearing surface is installed on top of the filled cells and profiled for safe vehicular use.

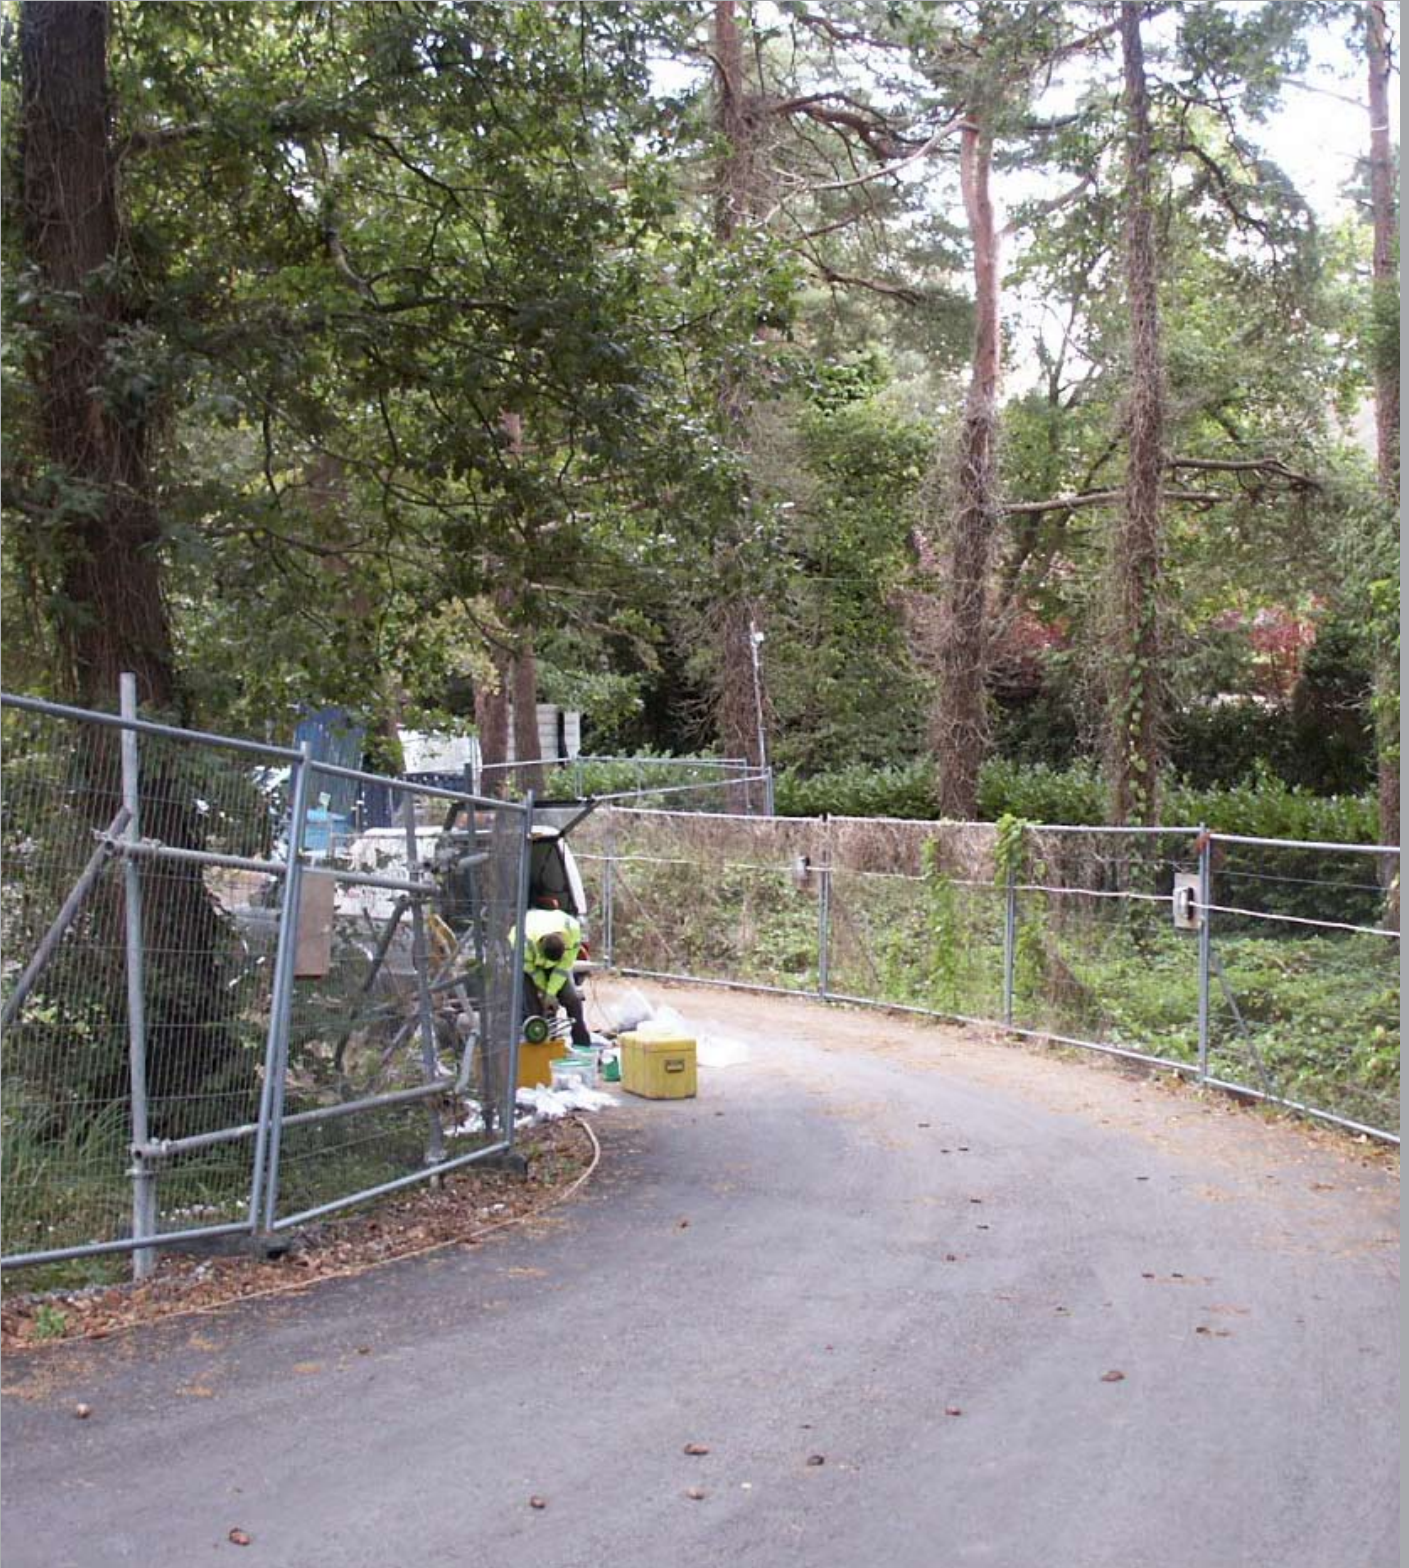
Two years on, the surface is still in use with no adverse impact on the adjacent trees.
