New trees in surfacing

TREE CONSULTANCY

# New trees in surfacing

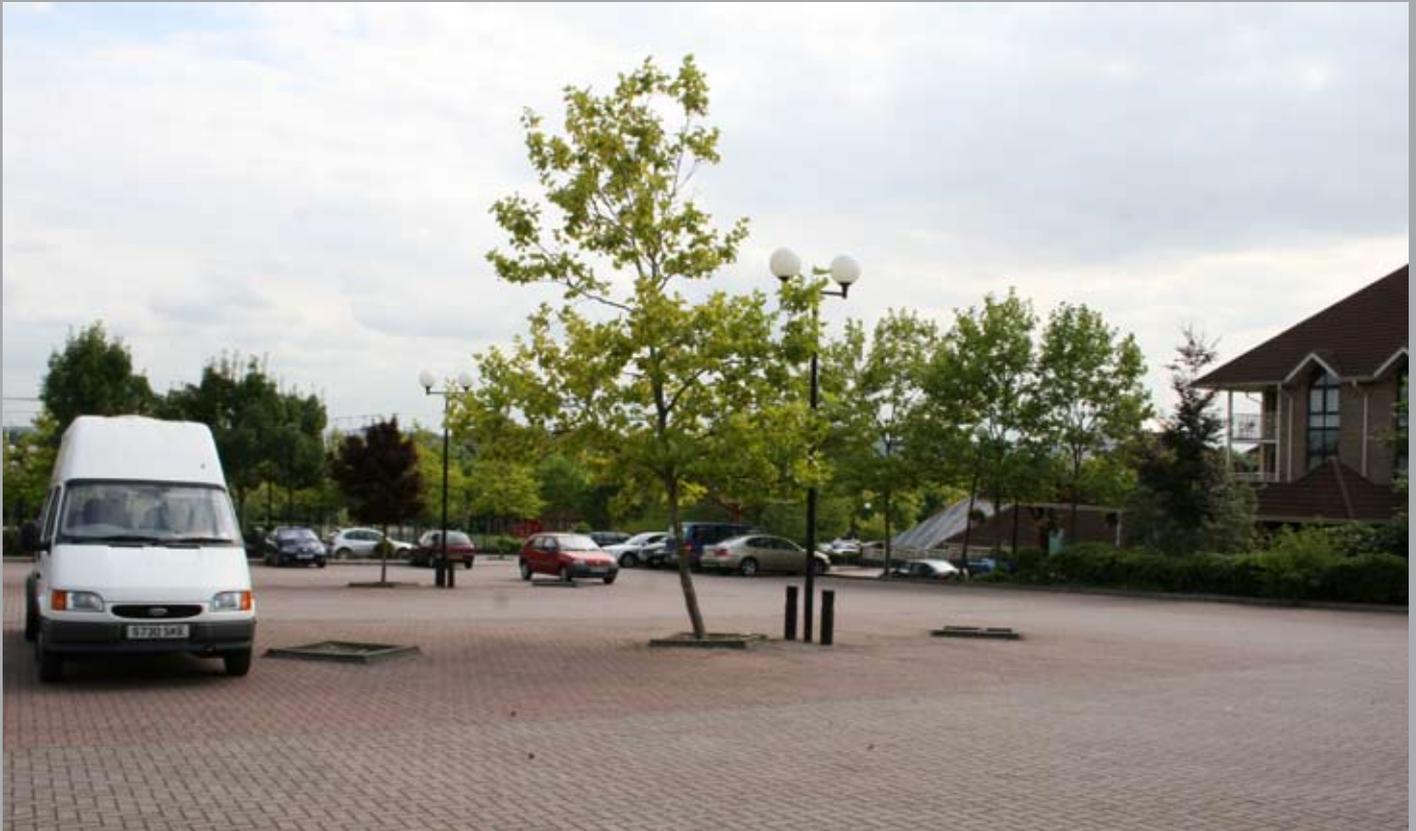
New trees planted into large expanses of hard standing often die or look unhealthy because of poor below-ground preparation. These failed trees create a subconscious impression of decay and deprivation that ultimately provides the definition between affluent neighbourhoods, where people want to live, and slums that the less fortunate cannot escape from!

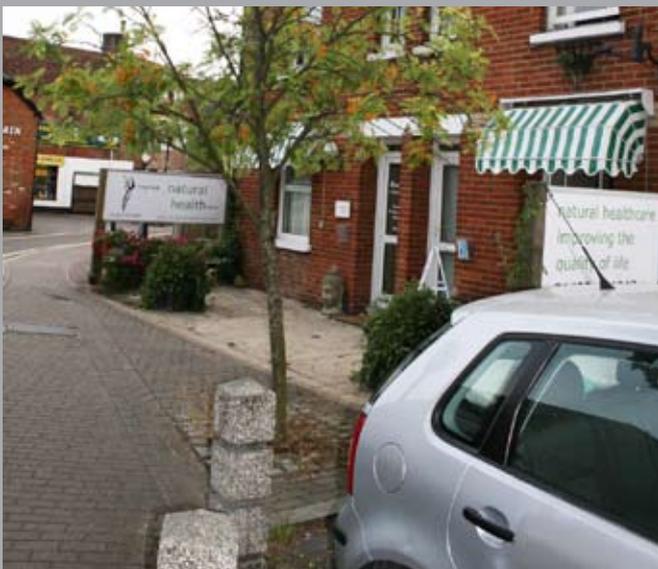
This dying rowan could have been a valuable asset to this commercial frontage if it had been planted into properly prepared soil with the correct surfacing above.

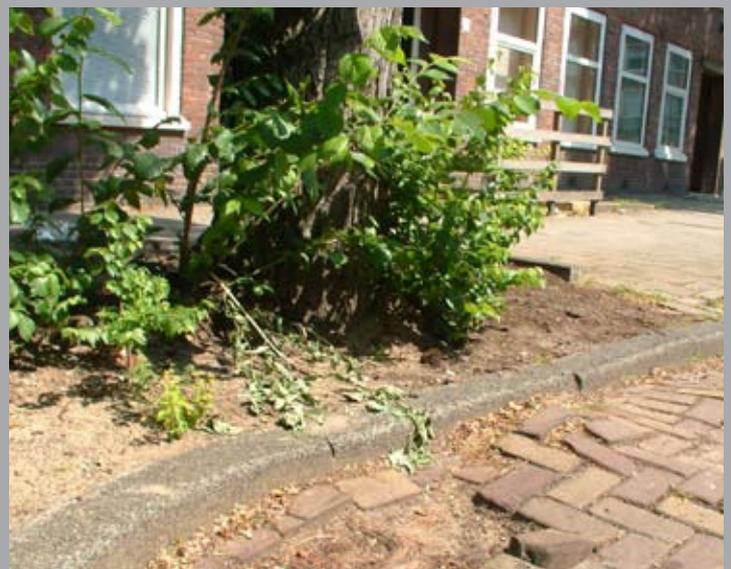
Failure to provide root deflectors when this tree was planted means that its roots are now damaging the paving. Severe root pruning that will shorten the life of the tree is a common consequence when there is not sufficient room to keep the roots.

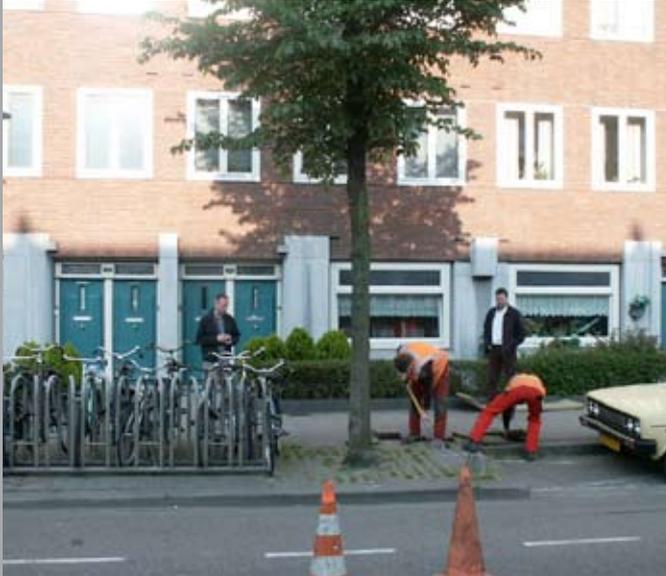
During a visit in 2005, Amsterdam City Council kindly agreed to excavate around this elm to show us why it had not caused any adjacent surfacing damage despite having been planted for seven years. It was planted into structural tree soil with permeable surfacing above.

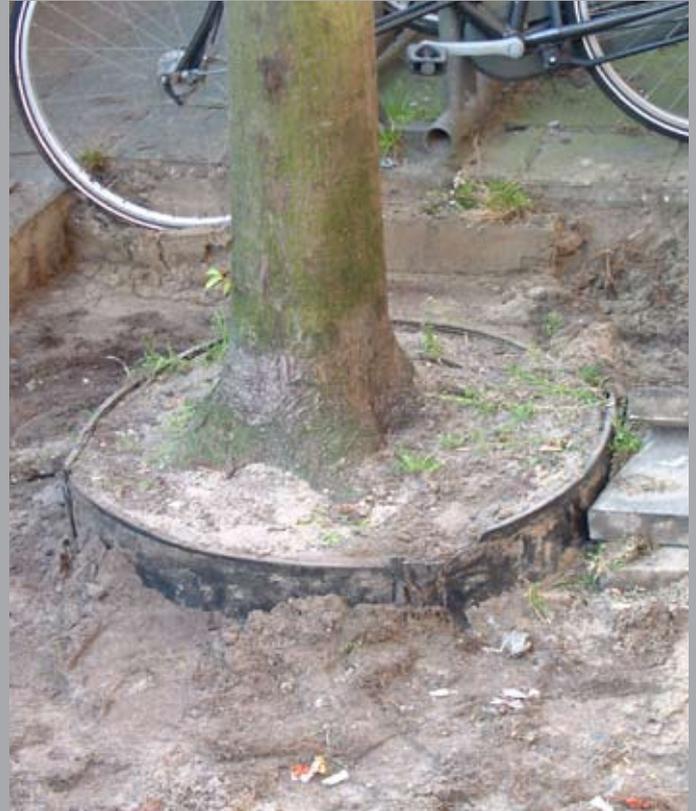
Heavy duty root deflectors installed around the root ball (black plastic) when the tree was planted have been effective at preventing large surface roots near the trunk.

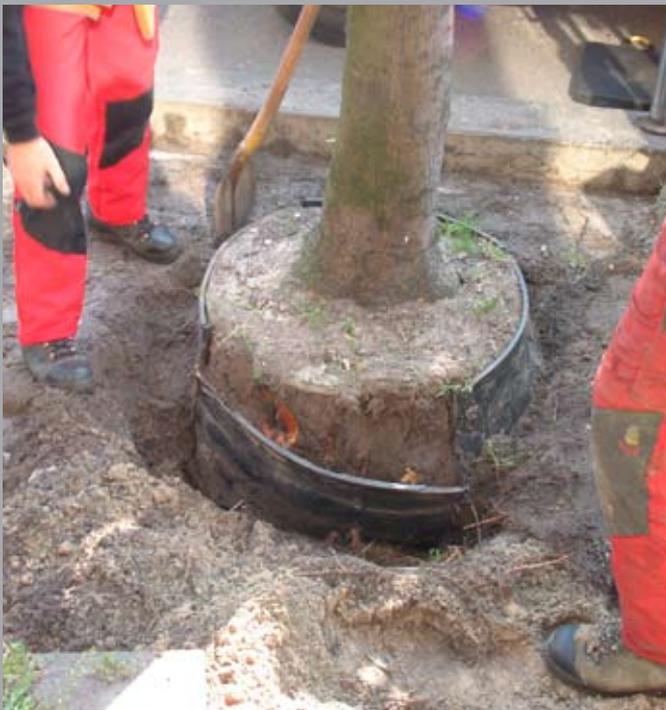
All the roots are forced to grow downwards and emerge into the surrounding soil below the black root deflectors.

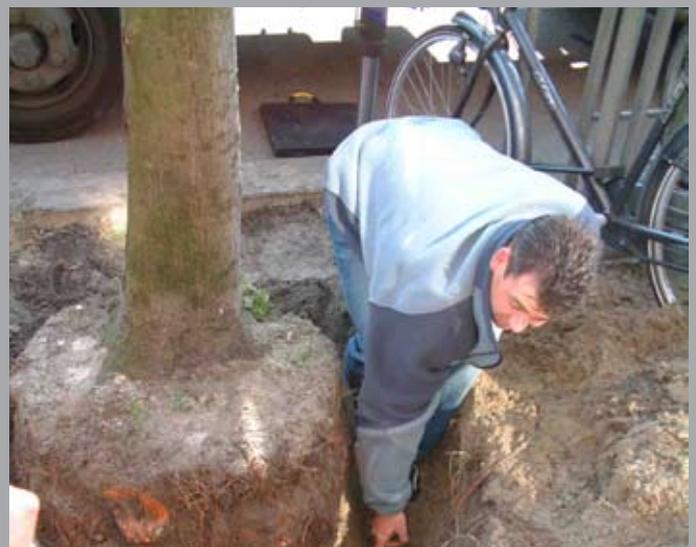
Further excavation and removal of the root deflectors shows the main structural roots emerging into the surrounding soil at about 60cm below the surface where they do not damage adjacent surfacing.

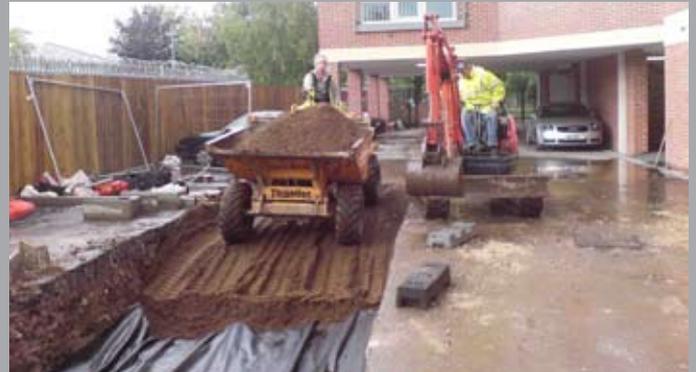
Existing services were covered with a geo-textile membrane and the special structural tree soil filled the planting pit.

Reading Borough Council conditioned the planting of four new semi-mature trees on this development, with a specific requirement for structural tree soil to be used beneath the surfacing. This carefully formulated soil mix has a high proportion of angular sand, which offers sufficient structural support for cars to use the surfacing above but also allows roots to grow through it. It provides a very effective solution to the problems of having trees and parking close together.

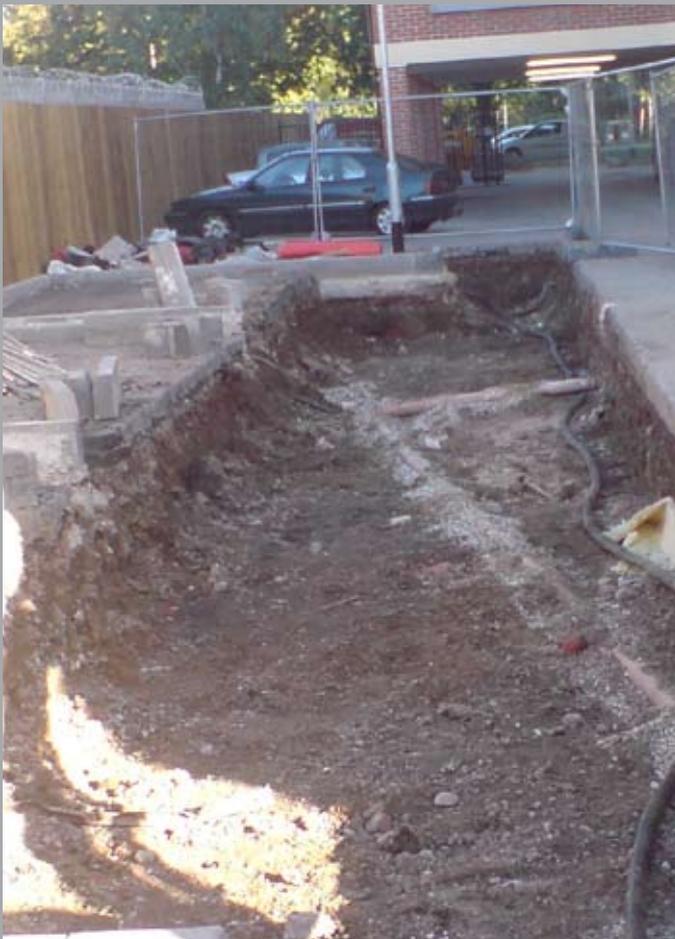
Once the main construction was completed, the linear planting pit was excavated to a depth of 1m in the parking area.

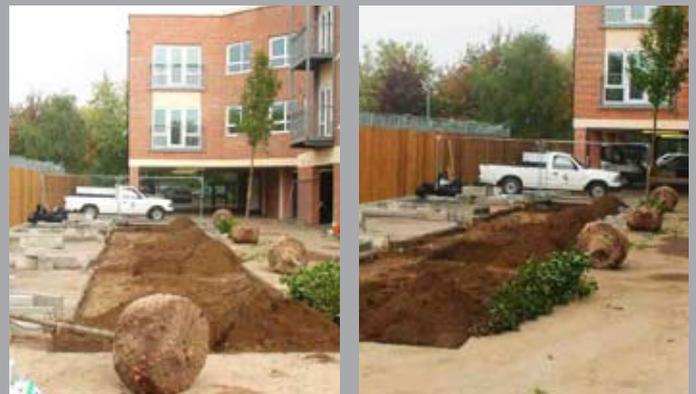
The four new root-balled trees were planted into the planting pits that lined up with landscaping strips between the parking bays.

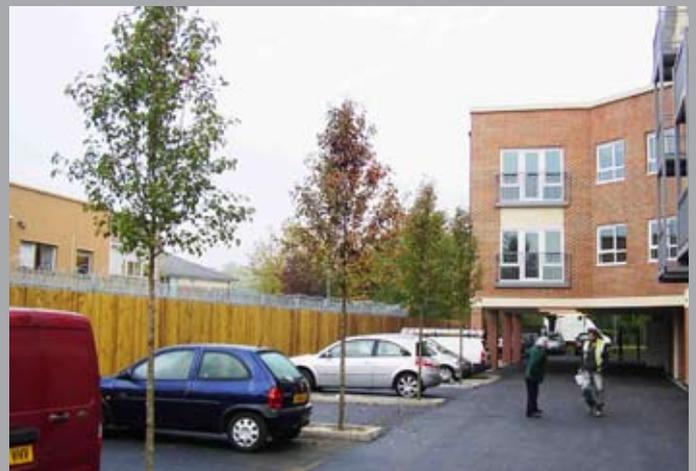
The new surfacing was installed on top of the tree soil and the trees begin to fulfil their planned landscape-softening role with very little loss of parking space. They will also provide much welcomed shade to the parked cars in the heat of summer.

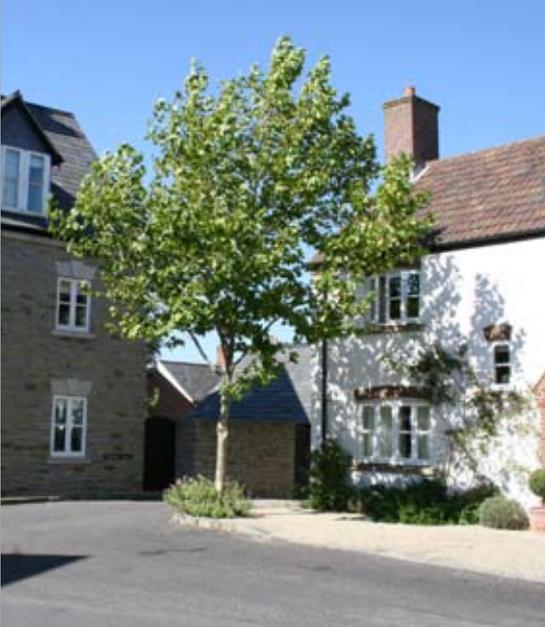
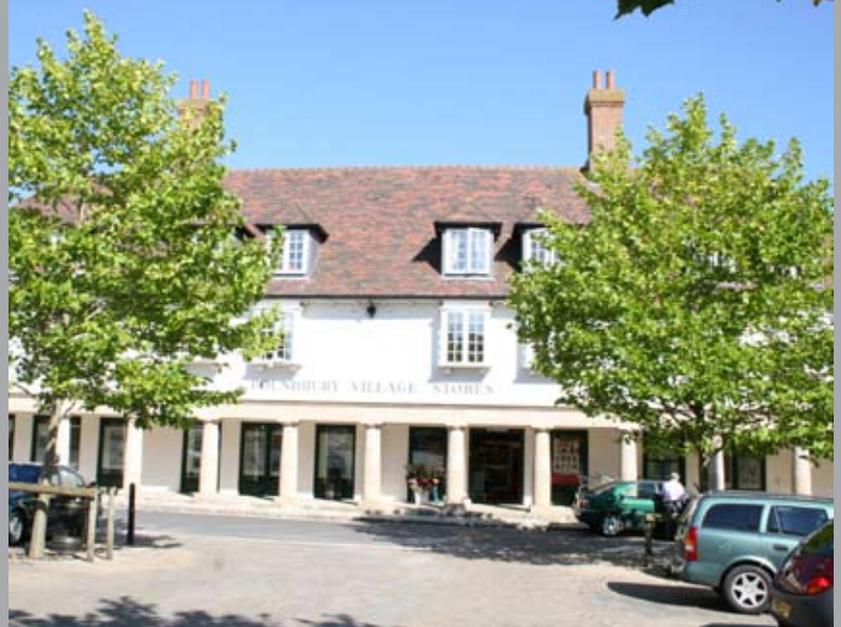
Without special below-ground preparation using structured tree soil, these trees would not be thriving as they are.

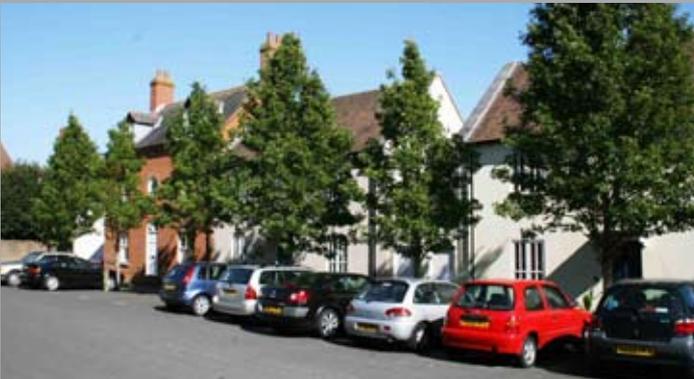
Structured tree soil allows trees and parking to occupy the same space, which is a very efficient way of providing visual amenity and functionality.

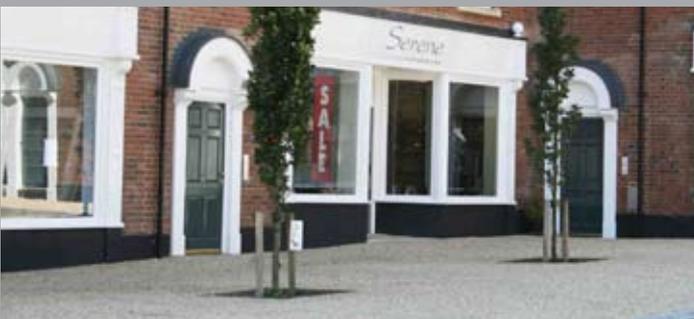
Similarly these trees are making a significant contribution to amenity without compromising pedestrian access to these narrow shop frontages.

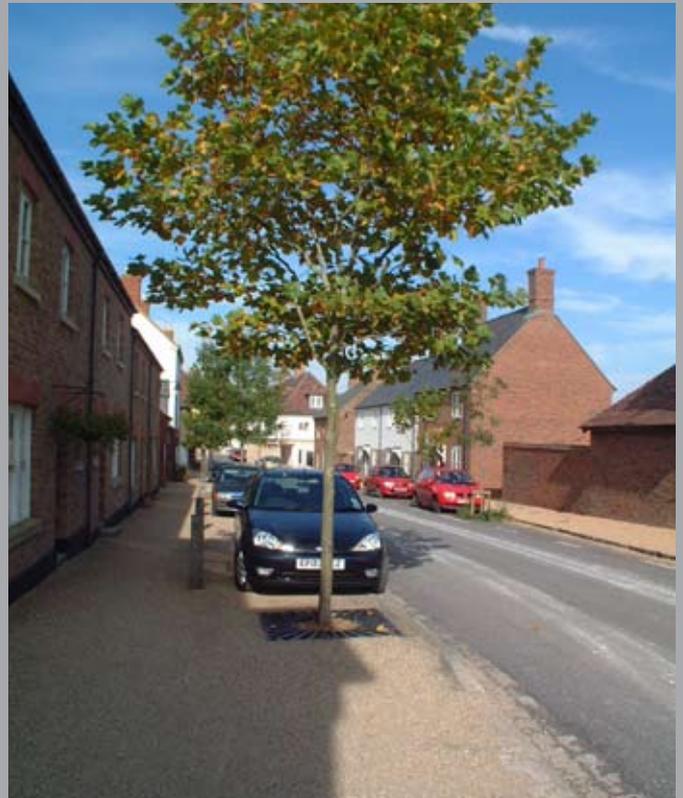
A combination of specially designed planting pits and structured tree soil means that these trees form green parking bay divisions within the highway without causing any surfacing damage.
