New trees in surfacing

TREE CONSULTANCY

Amsterdam case study

Reading case study

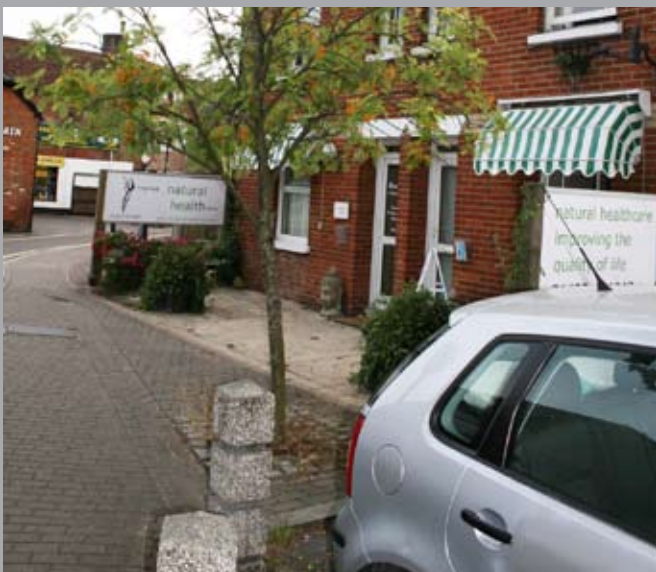
This dying rowan could have been a valuable asset to this commercial frontage if it had been planted into properly prepared soil with the correct surfacing above.

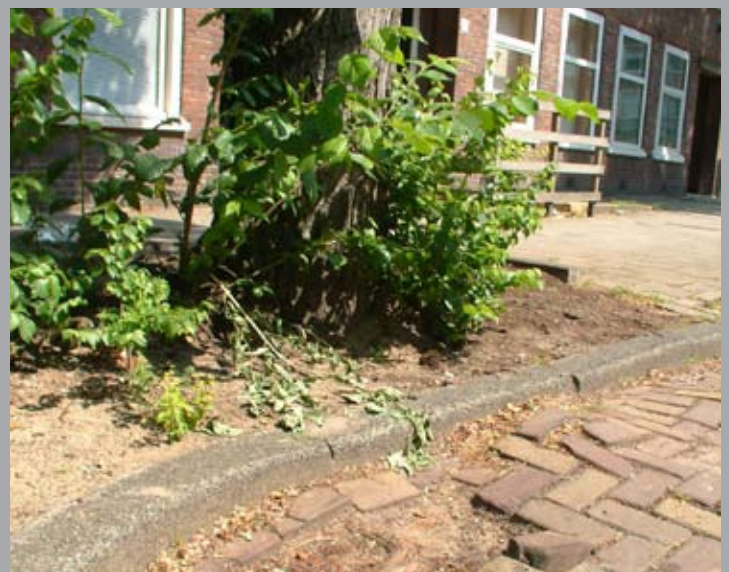
Failure to provide root deflectors when this tree was planted means that its roots are now damaging the paving. Severe root pruning that will shorten the life of the tree is a common consequence when there is not sufficient room to keep the roots.

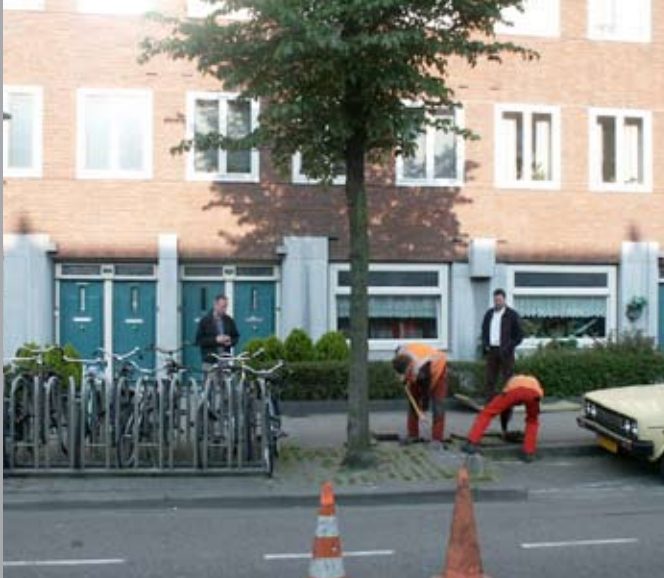
During a visit in 2005, Amsterdam City Council kindly agreed to excavate around this elm to show us why it had not caused any adjacent surfacing damage despite having been planted for seven years. It was planted into structural tree soil with permeable surfacing above.

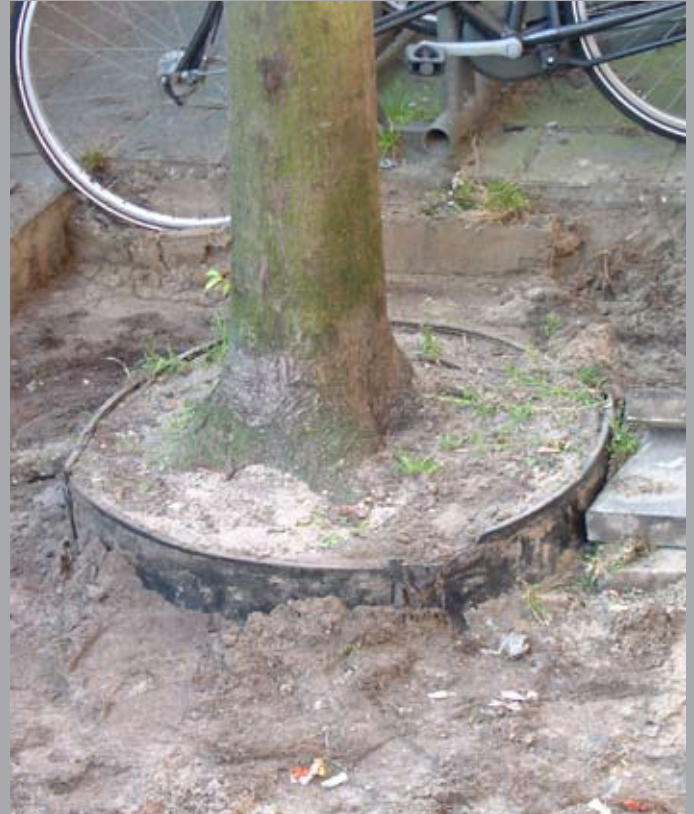
Heavy duty root deflectors installed around the root ball (black plastic) when the tree was planted have been effective at preventing large surface roots near the trunk.

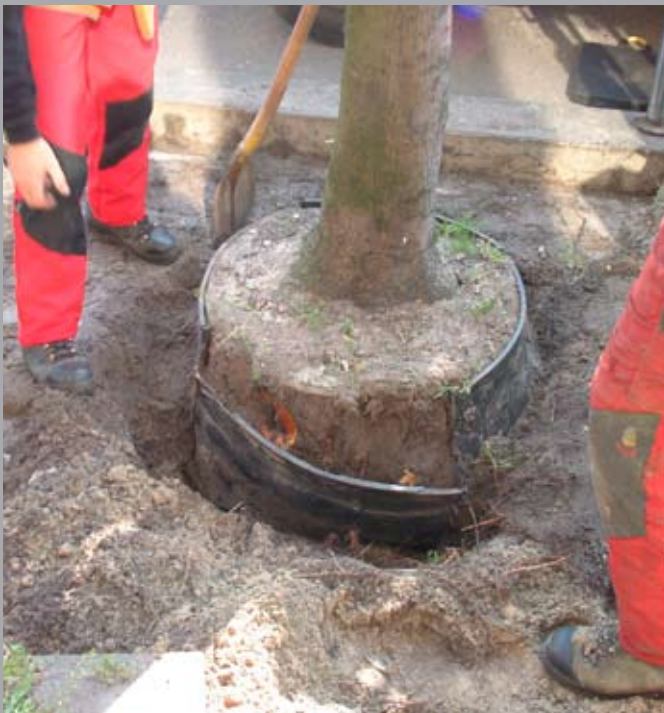
All the roots are forced to grow downwards and emerge into the surrounding soil below the black root deflectors.

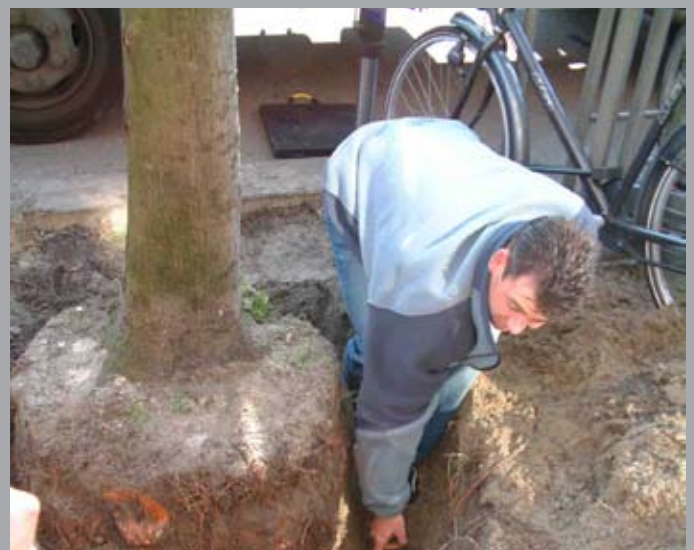
Further excavation and removal of the root deflectors shows the main structural roots emerging into the surrounding soil at about 60cm below the surface where they do not damage adjacent surfacing.

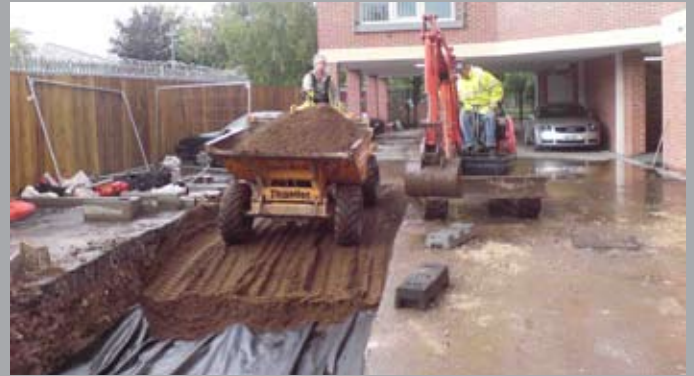
Existing services were covered with a geo-textile membrane and the special structural tree soil filled the planting pit.

Reading Borough Council conditioned the planting of four new semi-mature trees on this development, with a specific requirement for structural tree soil to be used beneath the surfacing. This carefully formulated soil mix has a high proportion of angular sand, which offers sufficient structural support for cars to use the surfacing above but also allows roots to grow through it. It provides a very effective solution to the problems of having trees and parking close together.

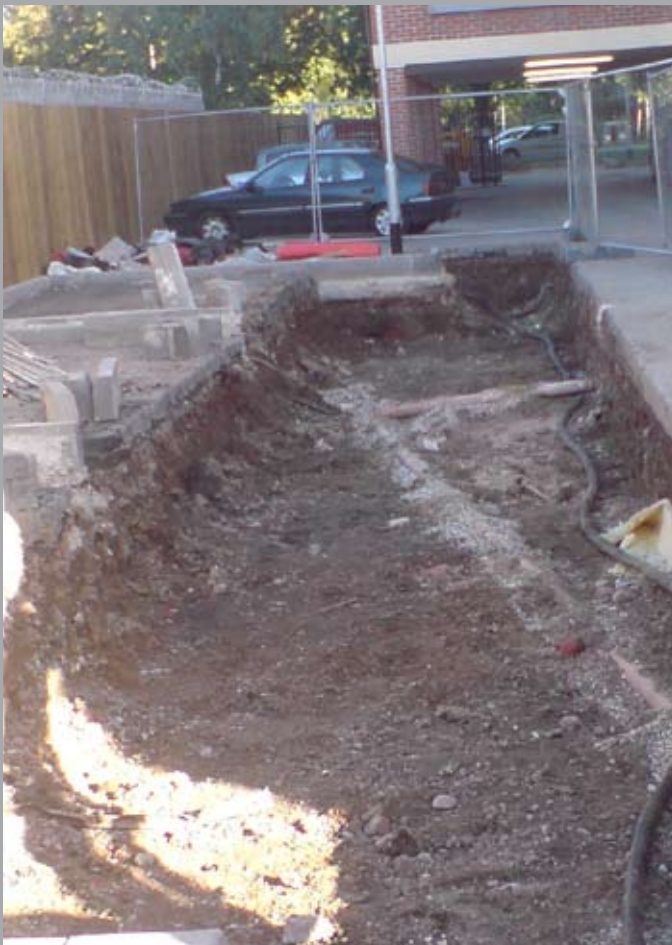
Once the main construction was completed, the linear planting pit was excavated to a depth of 1m in the parking area.

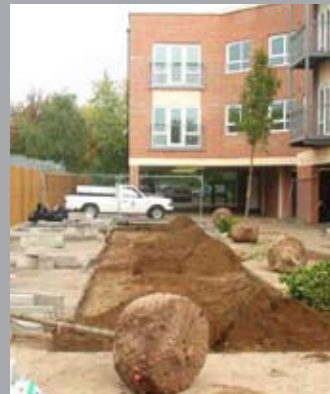
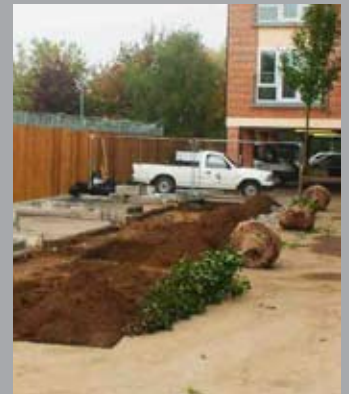
The four new root-balled trees were planted into the planting pits that lined up with landscaping strips between the parking bays.

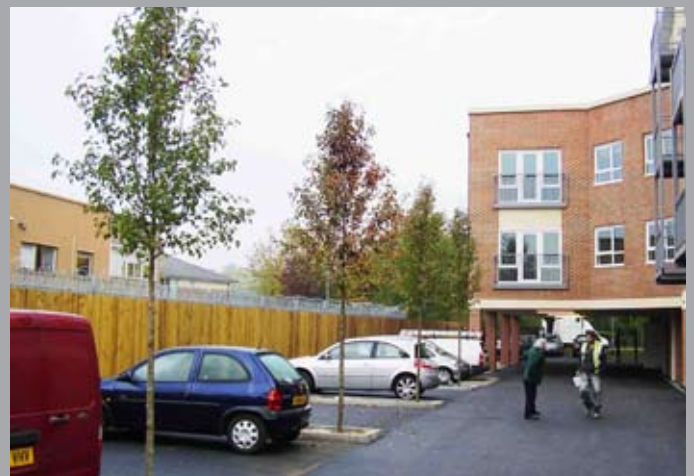
The new surfacing was installed on top of the tree soil and the trees begin to fulfil their planned landscape-softening role with very little loss of parking space. They will also provide much welcomed shade to the parked cars in the heat of summer.

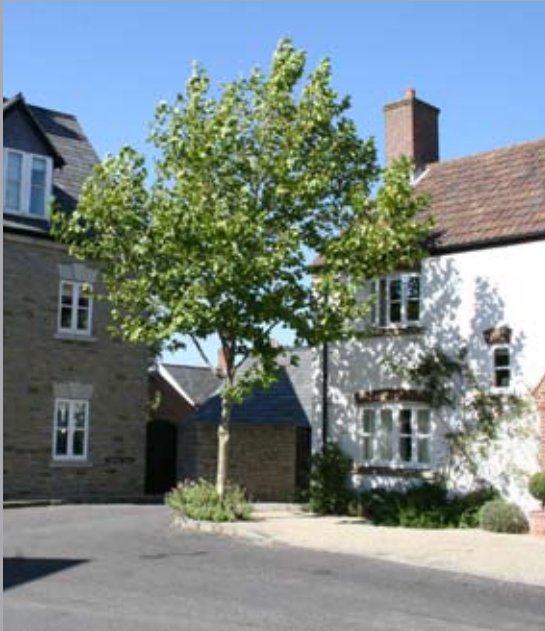
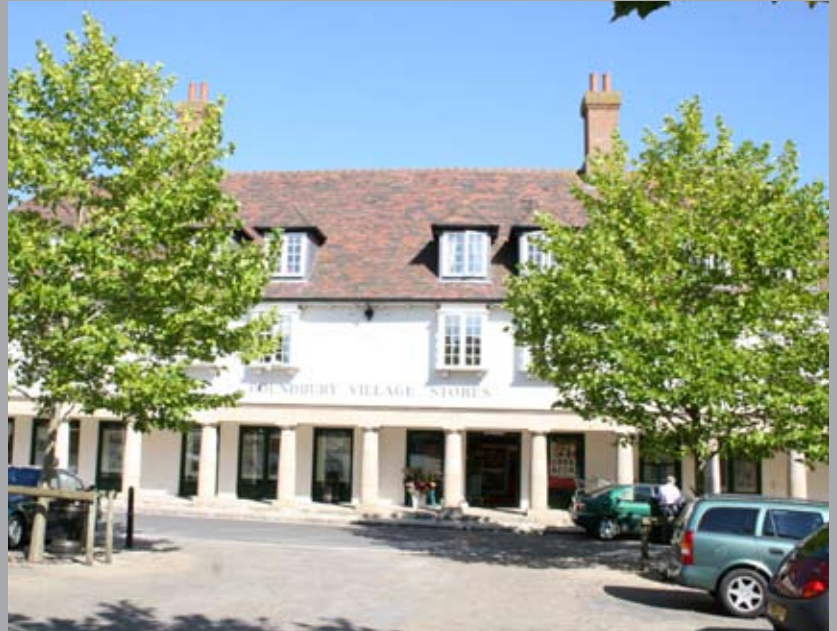
Without special below-ground preparation using structured tree soil, these trees would not be thriving as they are.

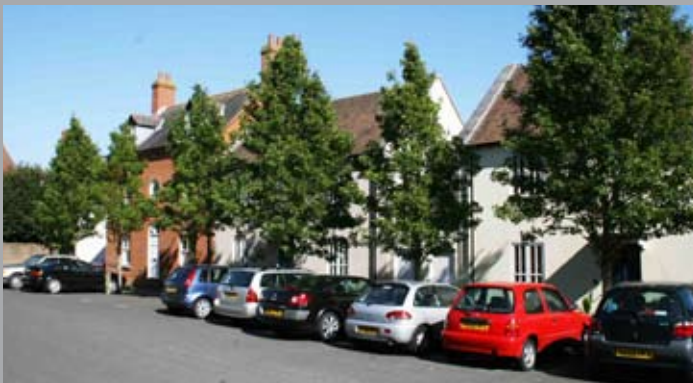
Structured tree soil allows trees and parking to occupy the same space, which is a very efficient way of providing visual amenity and functionality.

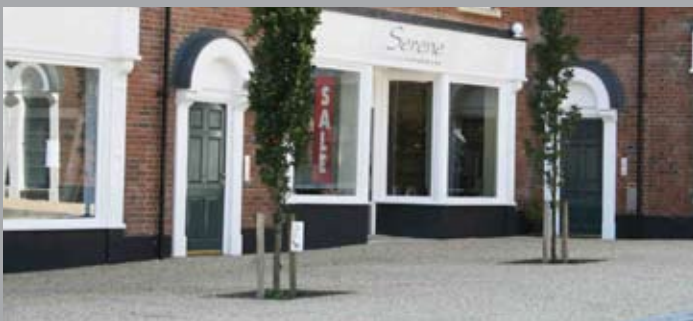
Similarly these trees are making a significant contribution to amenity without compromising pedestrian access to these narrow shop frontages.

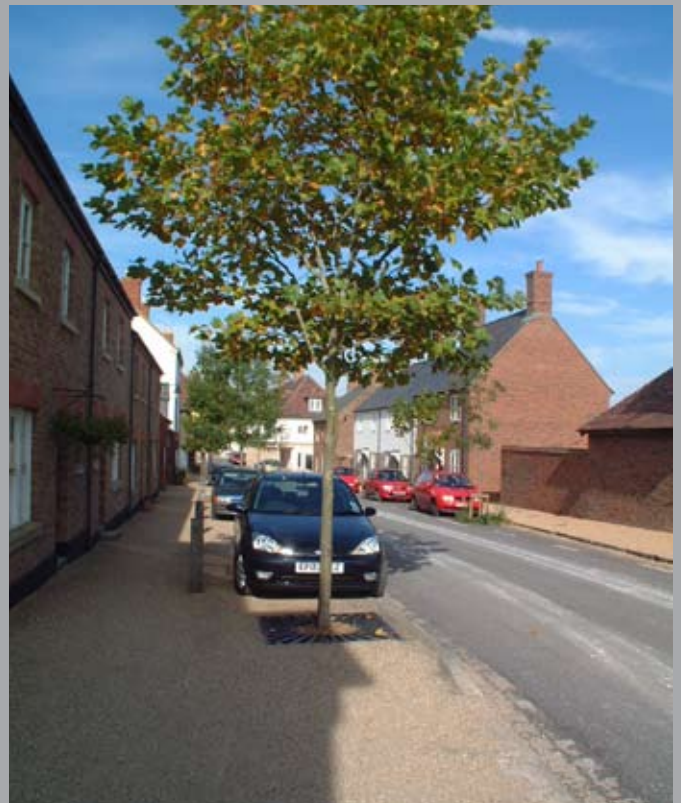
A combination of specially designed planting pits and structured tree soil means that these trees form green parking bay divisions within the highway without causing any surfacing damage.
